# The breakaway torque of the KW

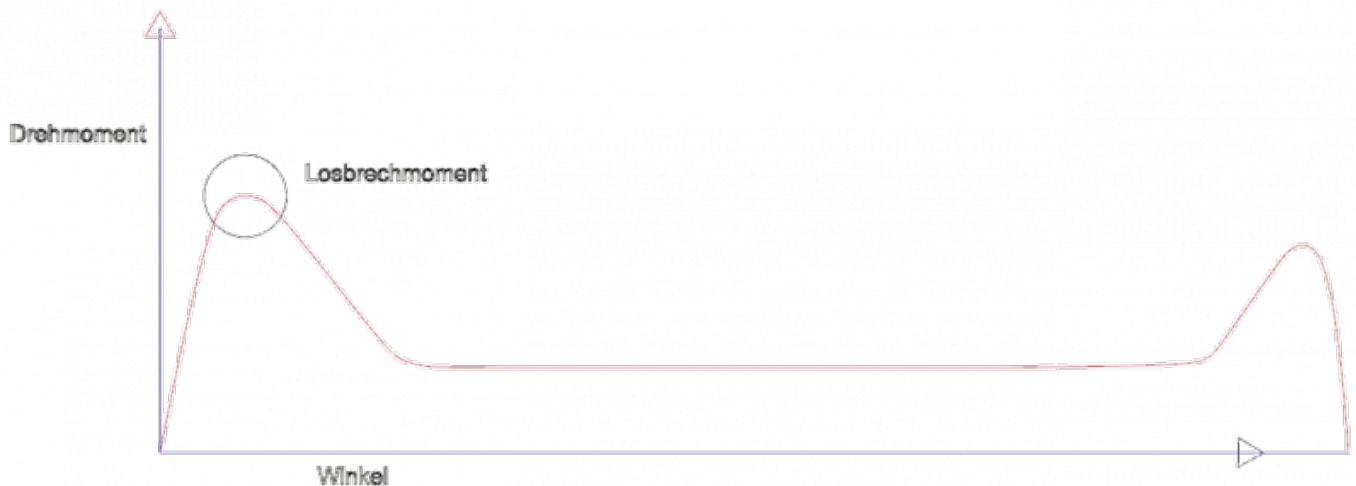
When you turn the propeller, the following behavior is observed: Initially, the breakaway torque is manifested by increased resistance when you try to turn the propeller. If it rotates, we feel a lower and more even effort. If you now stop the rotation, you will notice a jerky stop of the propeller. This is roughly illustrated by the following curve.

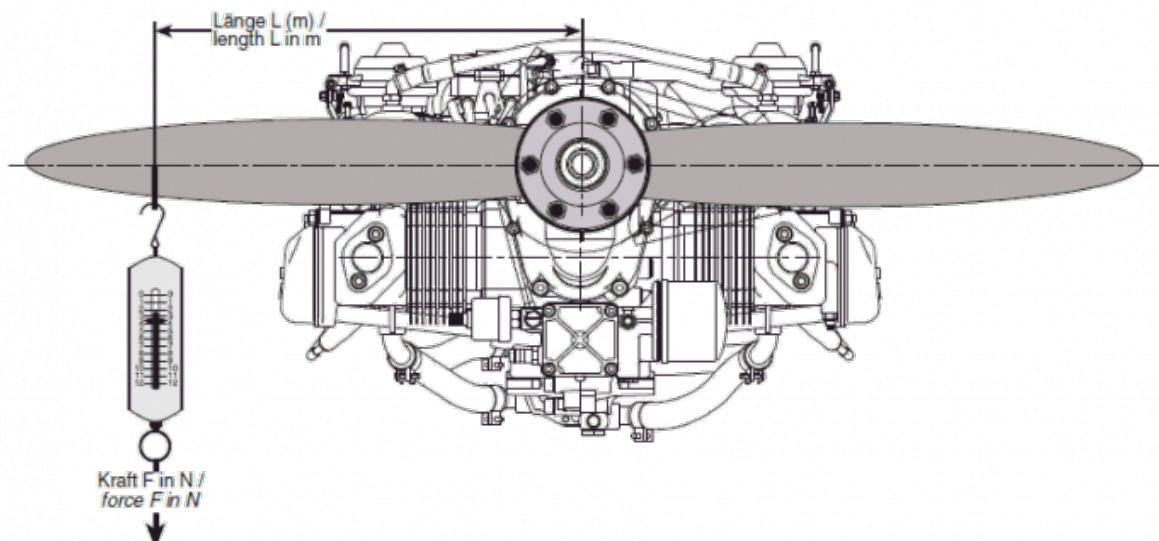
### Measuring torque required to turn crank drive

## 150 Nm

If we take into account the gear ratio of 2.43:1 for the 912 S/ULS, this means a **breakaway torque of 61.73 Nm at the crankshaft.**

If a breakaway torque of over 15 Nm is detected on the crankshaft of an engine during maintenance and it is subsequently disassembled, the typical rough, gray discolored areas can be seen in the area of the main bearings on the housing interfaces.

Measurements of the remaining crankshaft bearing play would show a **play of 0 (ZERO) or less.**

Engine runs sluggishly	
Step	Procedure
1	Remove spark plug connector and remove 1 spark plug from each cylinder.
2	<p>Torque must be determined with a suitable jig.</p> <p>To do this, determine the maximum occurring torque on the propeller shaft necessary to move the whole crank drive.</p> <p>The torque must be max. 150 Nm (110.64 ft.lb).</p> <p>If the max. permissible torque is exceeded, following inspections are to be performed:</p> <ul style="list-style-type: none"> <li>- Carry out detailed inspection of the affected gearbox components</li> <li>- Carry out detailed inspection of crank driv</li> </ul>
