... what can happen with a defective wastegate flap servo

... the TCU warning lights indicate a possible defect in the wastegate flap servo and what the consequences can be.

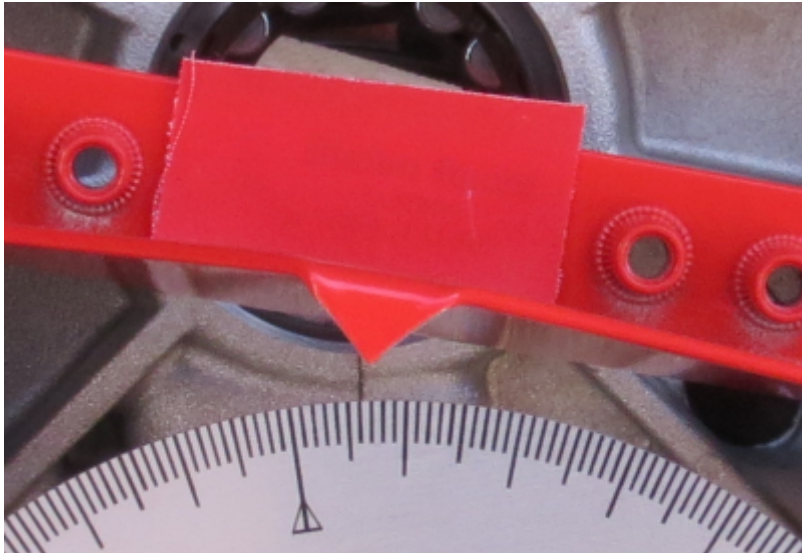
Turn the piston to the piston stopper at cylinder 2 and read the position on the degree disk.

Here you can clearly see that the crankshaft is rotated by approx. 6° between the two measured cylinders, in this case between cylinders 1 and 2. The measured value for cylinders 3 and 4 was also 6°.

This means that the crankshaft is only twisted between cylinders 1 and 2.

For cylinder 1, the piston is therefore advancing by 6°.

As you can imagine, there was a hard lump in Gustav's face - **the crankshaft needs to be replaced.**
