The cooling run of the turbocharger

... and what happens if you don't comply with it

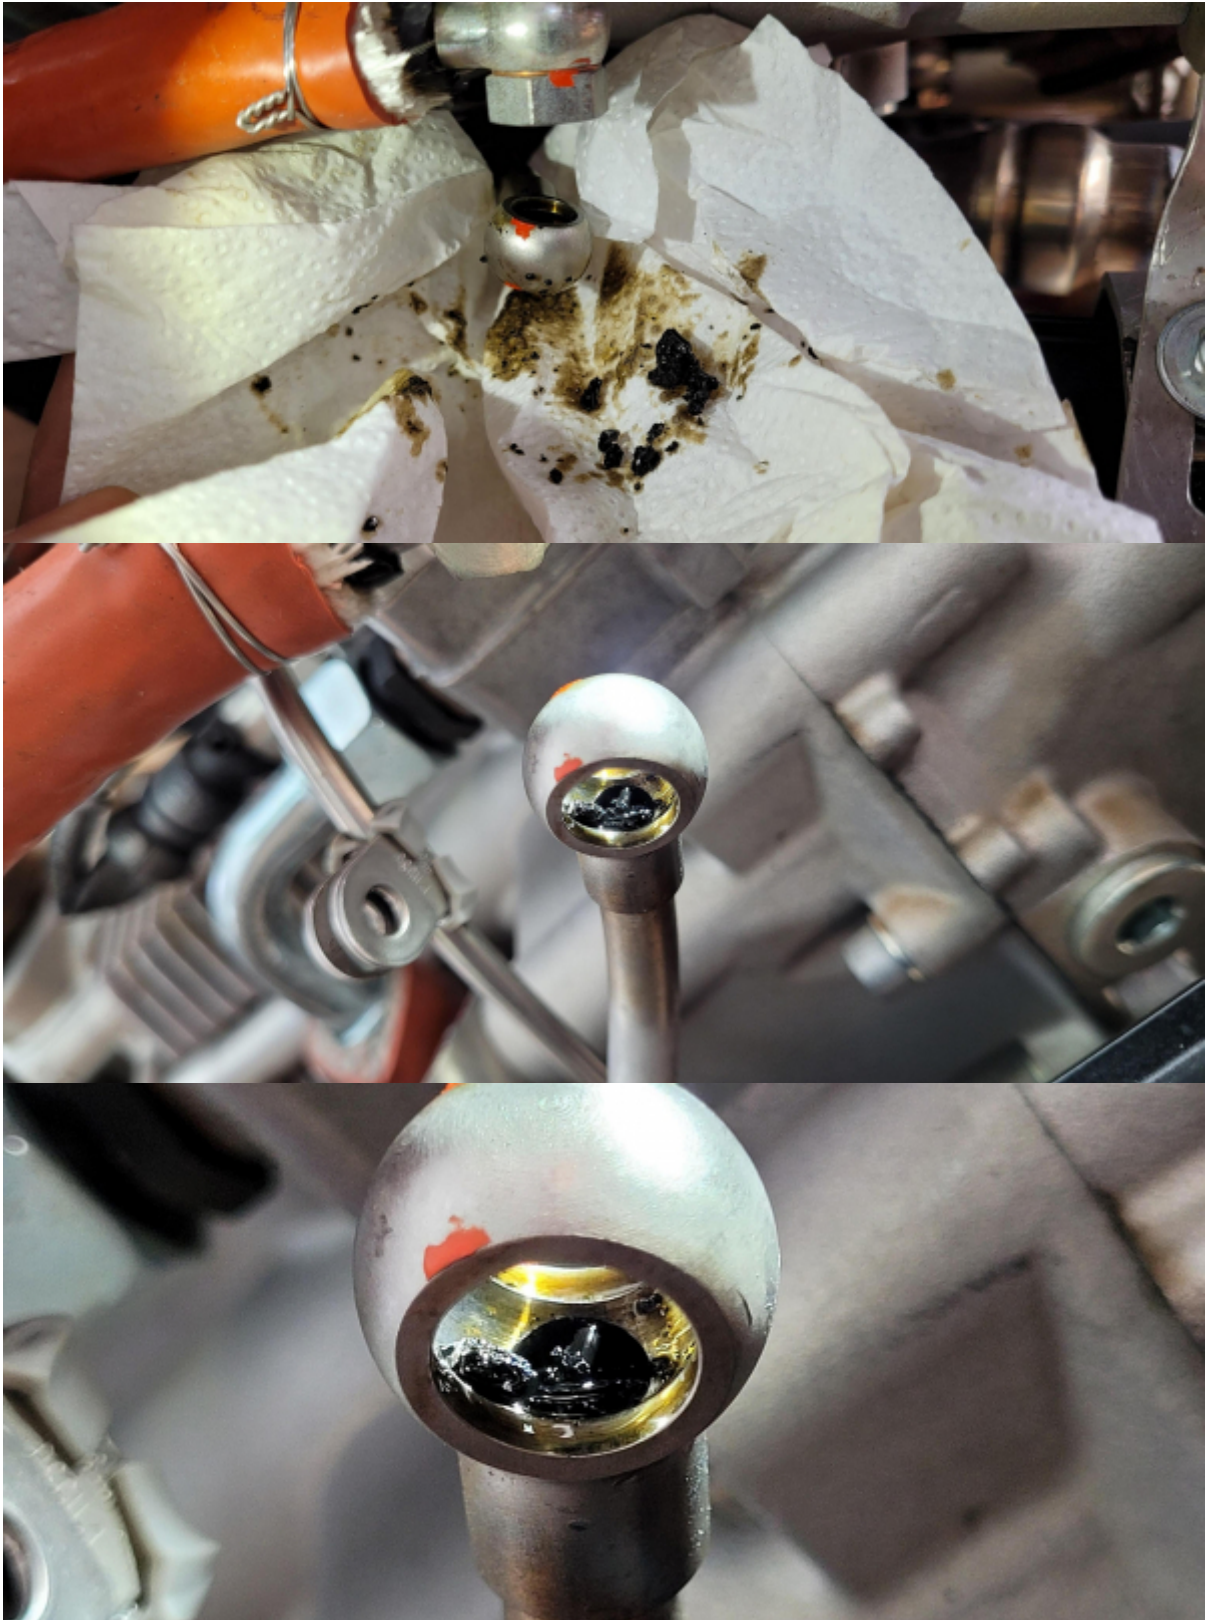
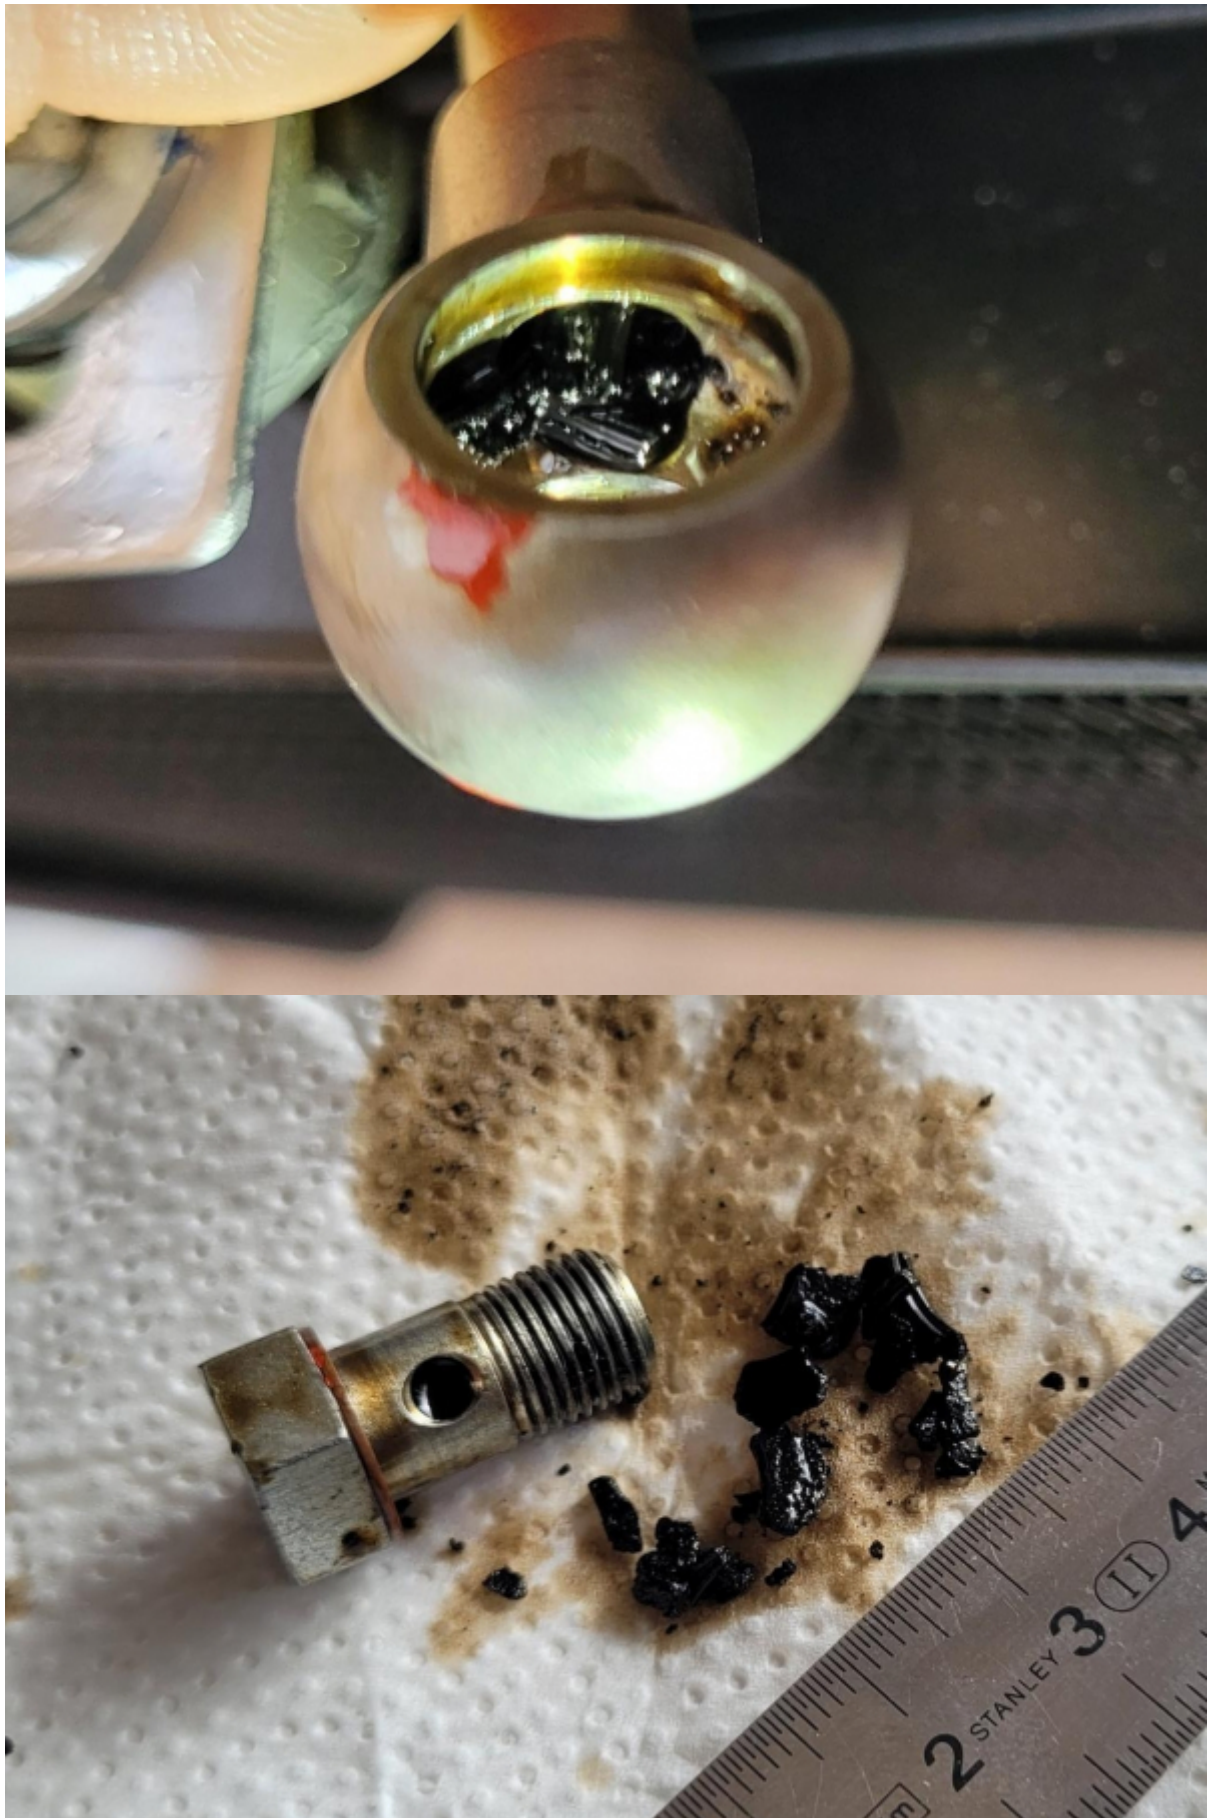
1)

Of course, this was also the case here, which is why I was so surprised to find such lumps.

However, it is quite clear that the „good outcome“ of the story is due to the fact that the banjo bolt in front of the oil pump was not yet completely blocked. The amount of oil that could still pass through here was apparently just under the amount that was pumped to the center section to lubricate the turbocharger. The quantity that was not returned caused the oil to overflow at the points where the turbocharger shaft was positioned. As a result, the oil was forced out on both sides of the turbo, some of which ended up in the exhaust and some in the airbox, causing the oil plume.

they are caused by coking of the engine oil on the shaft, mainly in the area of the bearing at the turbine wheel (the side that is driven by the exhaust gases). When the engine is running, the engine oil cannot coke here, as there is always a certain amount of cooling due to the lubrication process. If the oil is not pumped and the shaft is not yet cold enough, the oil that has come to rest boils away and forms nice lumps of carbon. These then eventually fall into the oil sump, are sucked towards the oil pump by the suction line and possibly clog the banjo bolt in front of the oil pump.

The moral of the story, don't shorten the cooling run!

This is another reason why I always recommend removing the oil reservoir and checking for carbon crumbs when changing the oil. Small black crumbs in the oil filter mat are another warning sign!

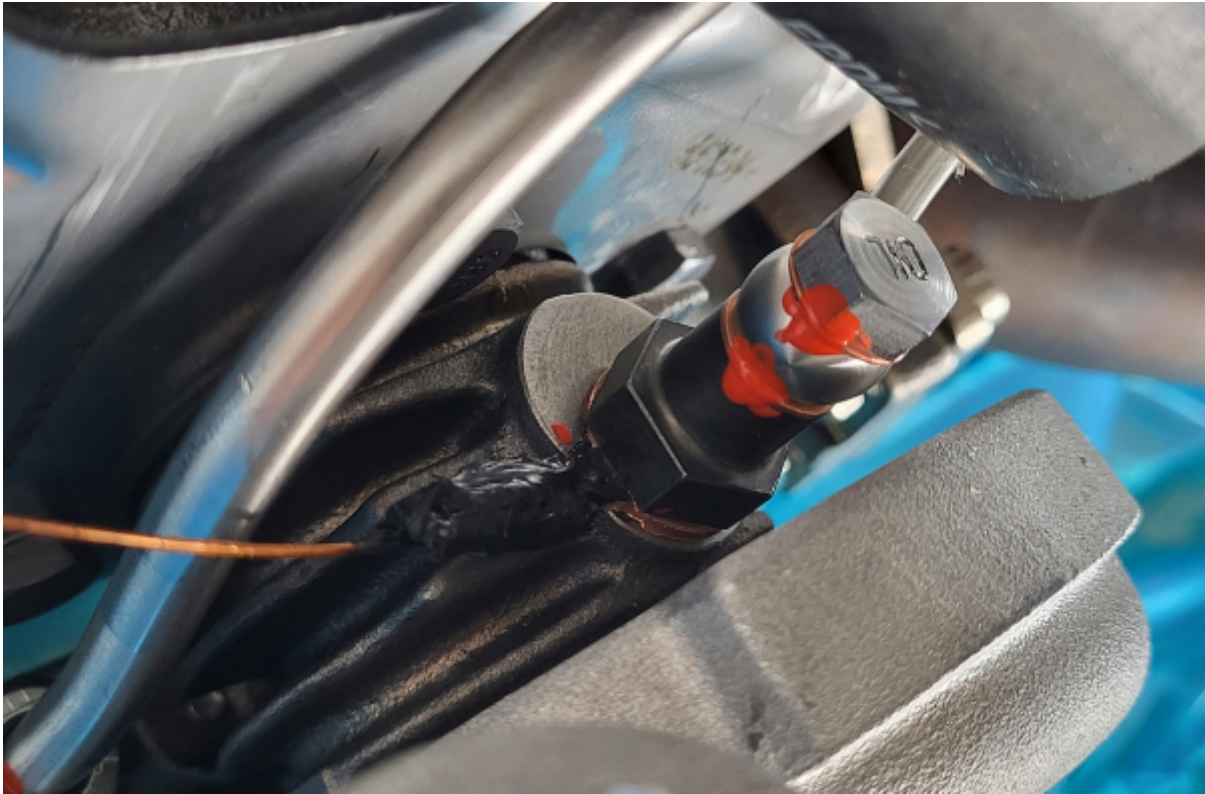
We fitted the sensor to the oil inlet of the center section of a Turbo-Dimona as a replacement for the copper seal that is fitted under the valve housing.

We had just 120°C in flight after 5 minutes of take-off power. After landing and the cooling run approx. 100°C .

The temperature rose to approx. 130°C after parking.

However, these are temperatures that do not lead to carbonization.

Consequently, carbon formation only takes place on the shaft in the area of the turbine wheel.

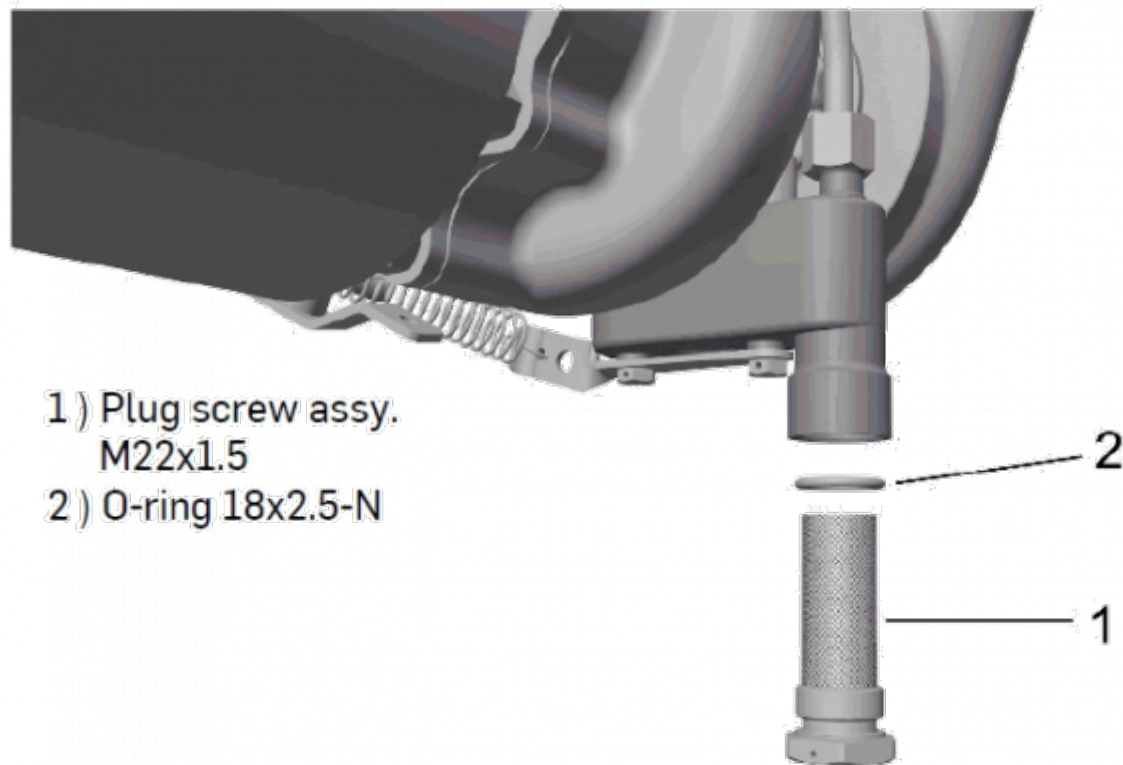
[SI-914-039](#) Introduction of a new oil sump assy for ROTAX Engine Type 914 (Series) from 20.02.2023

A strainer is integrated into the oil sump vessel here, which prevents carbon crumbs of one size from reaching the banjo bolt of the return line, which can clog it.

I recommend everyone to install this unfortunately not quite cheap part.
