The cooling run of the turbocharger

... and what happens if you don't comply with it

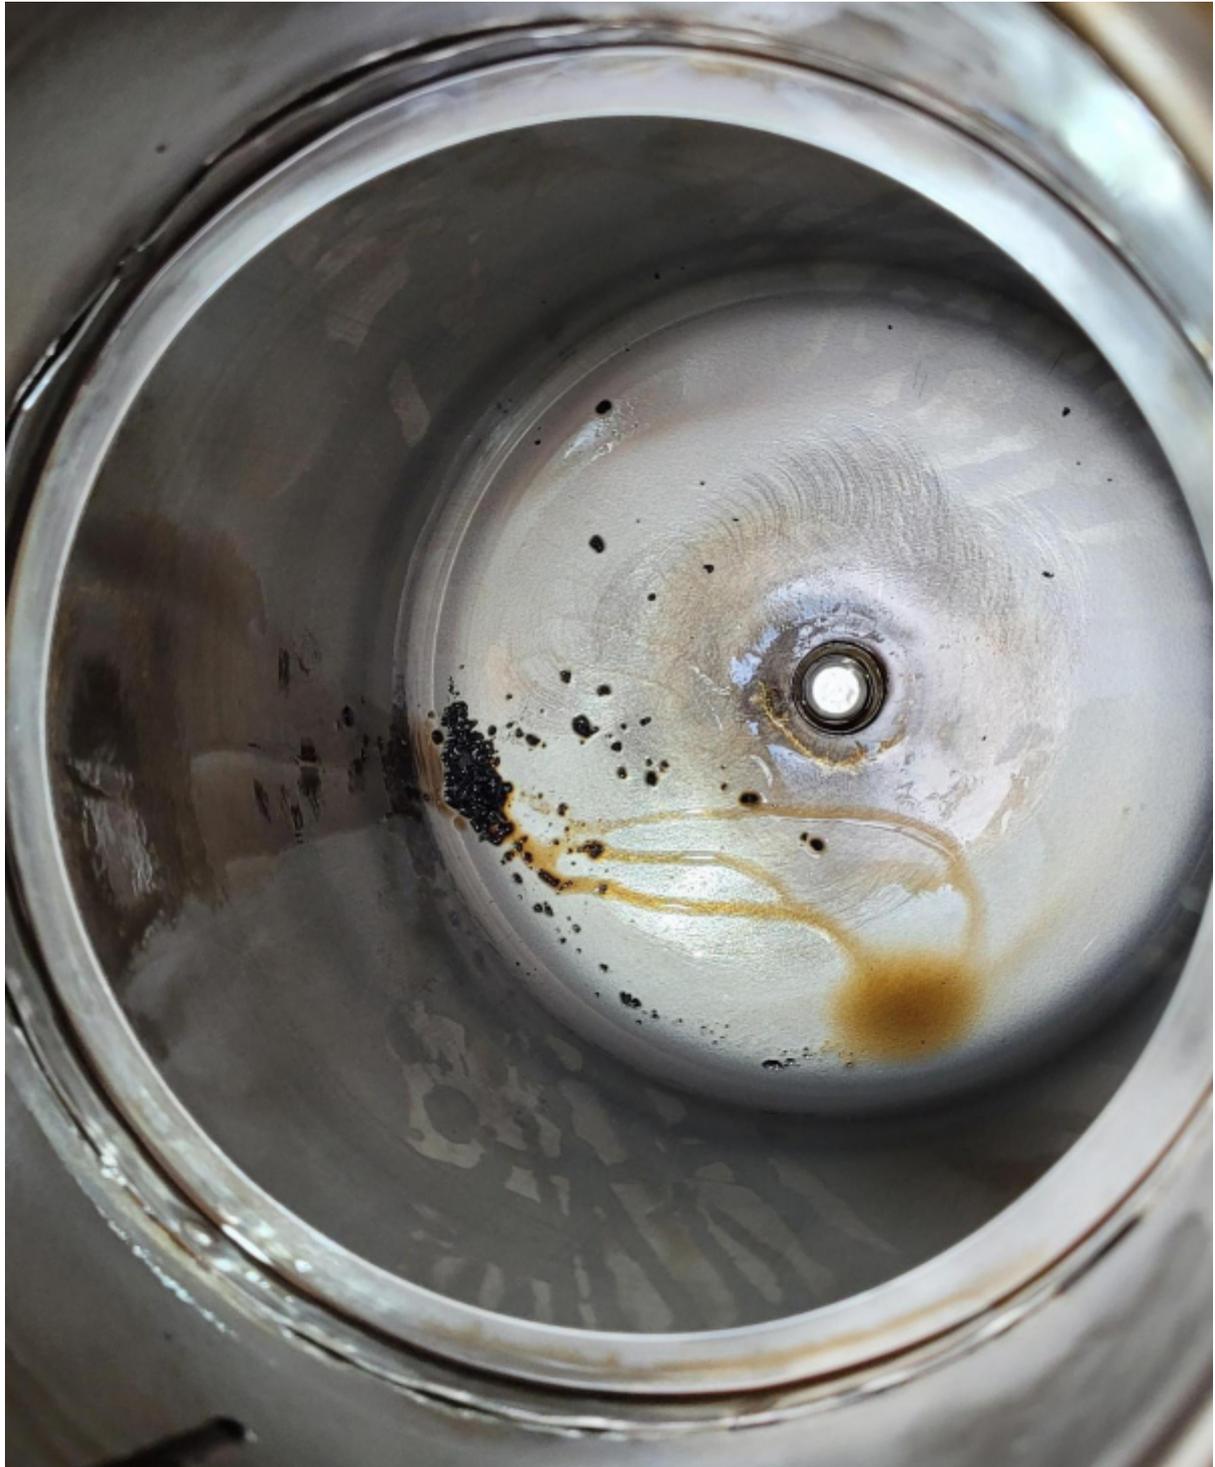
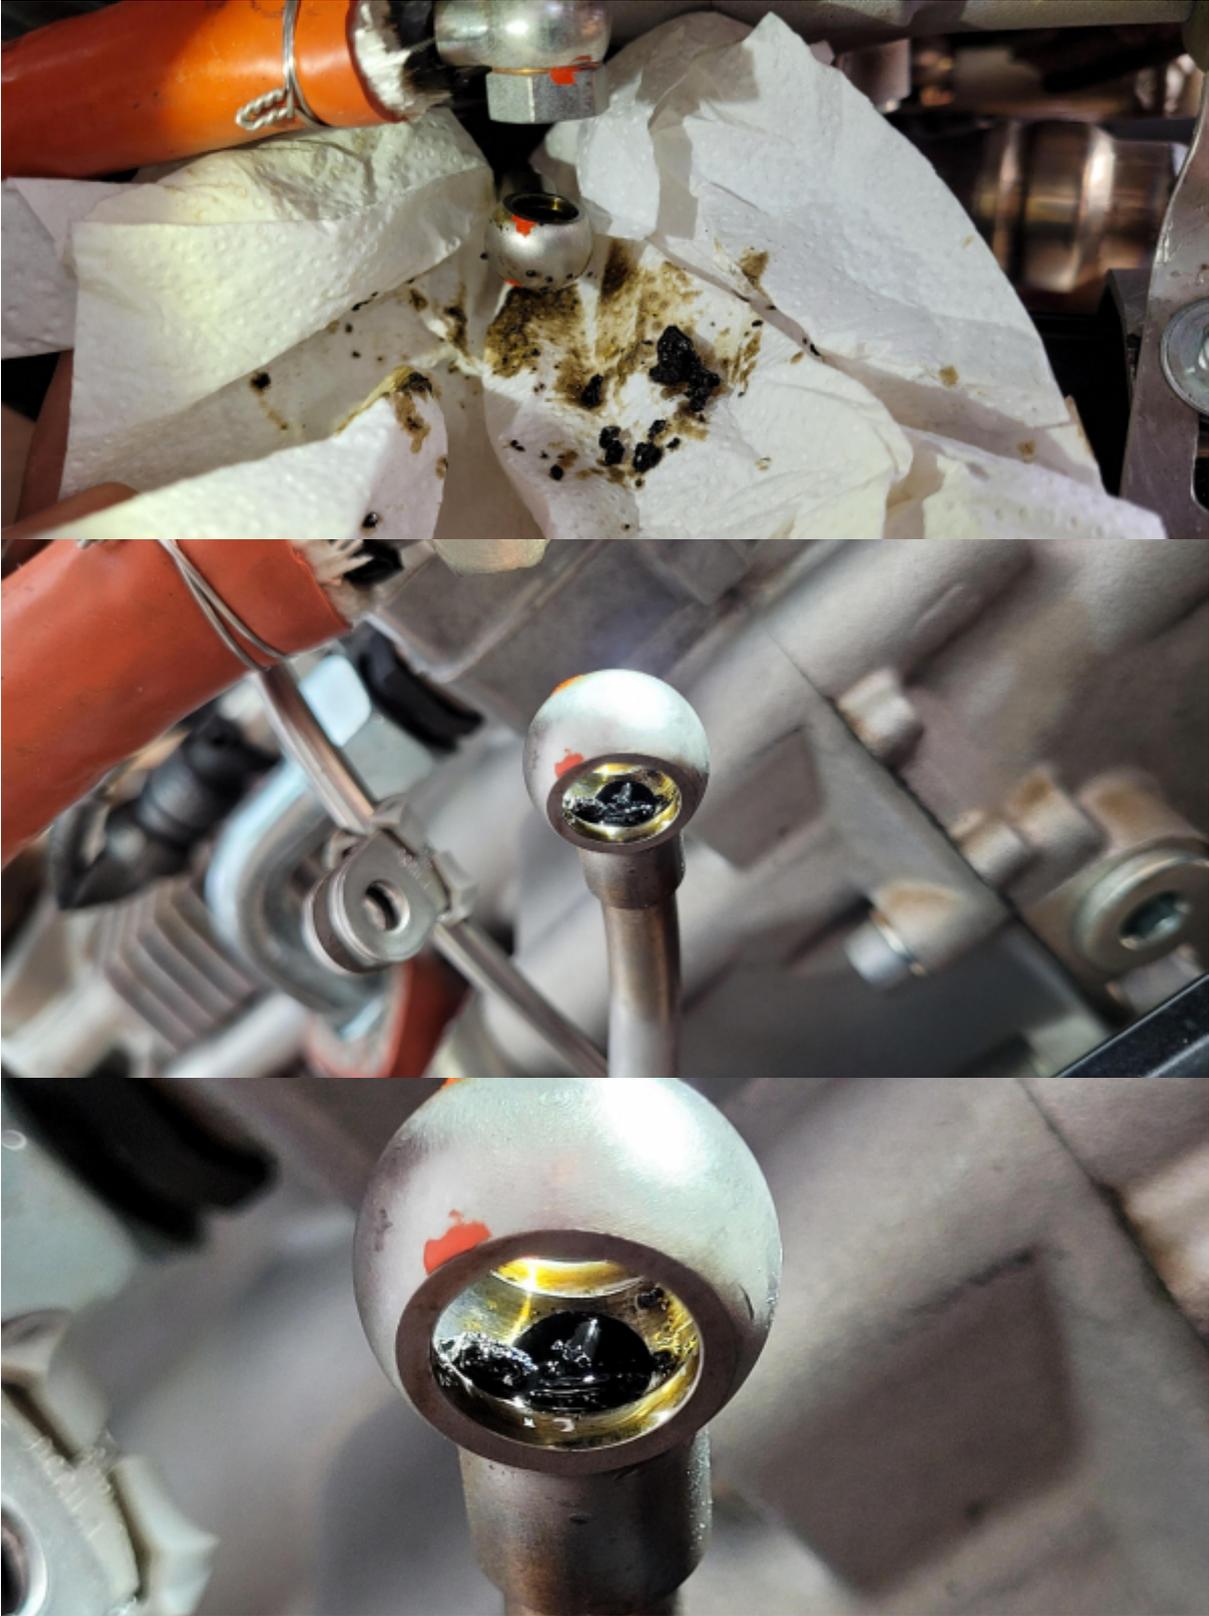
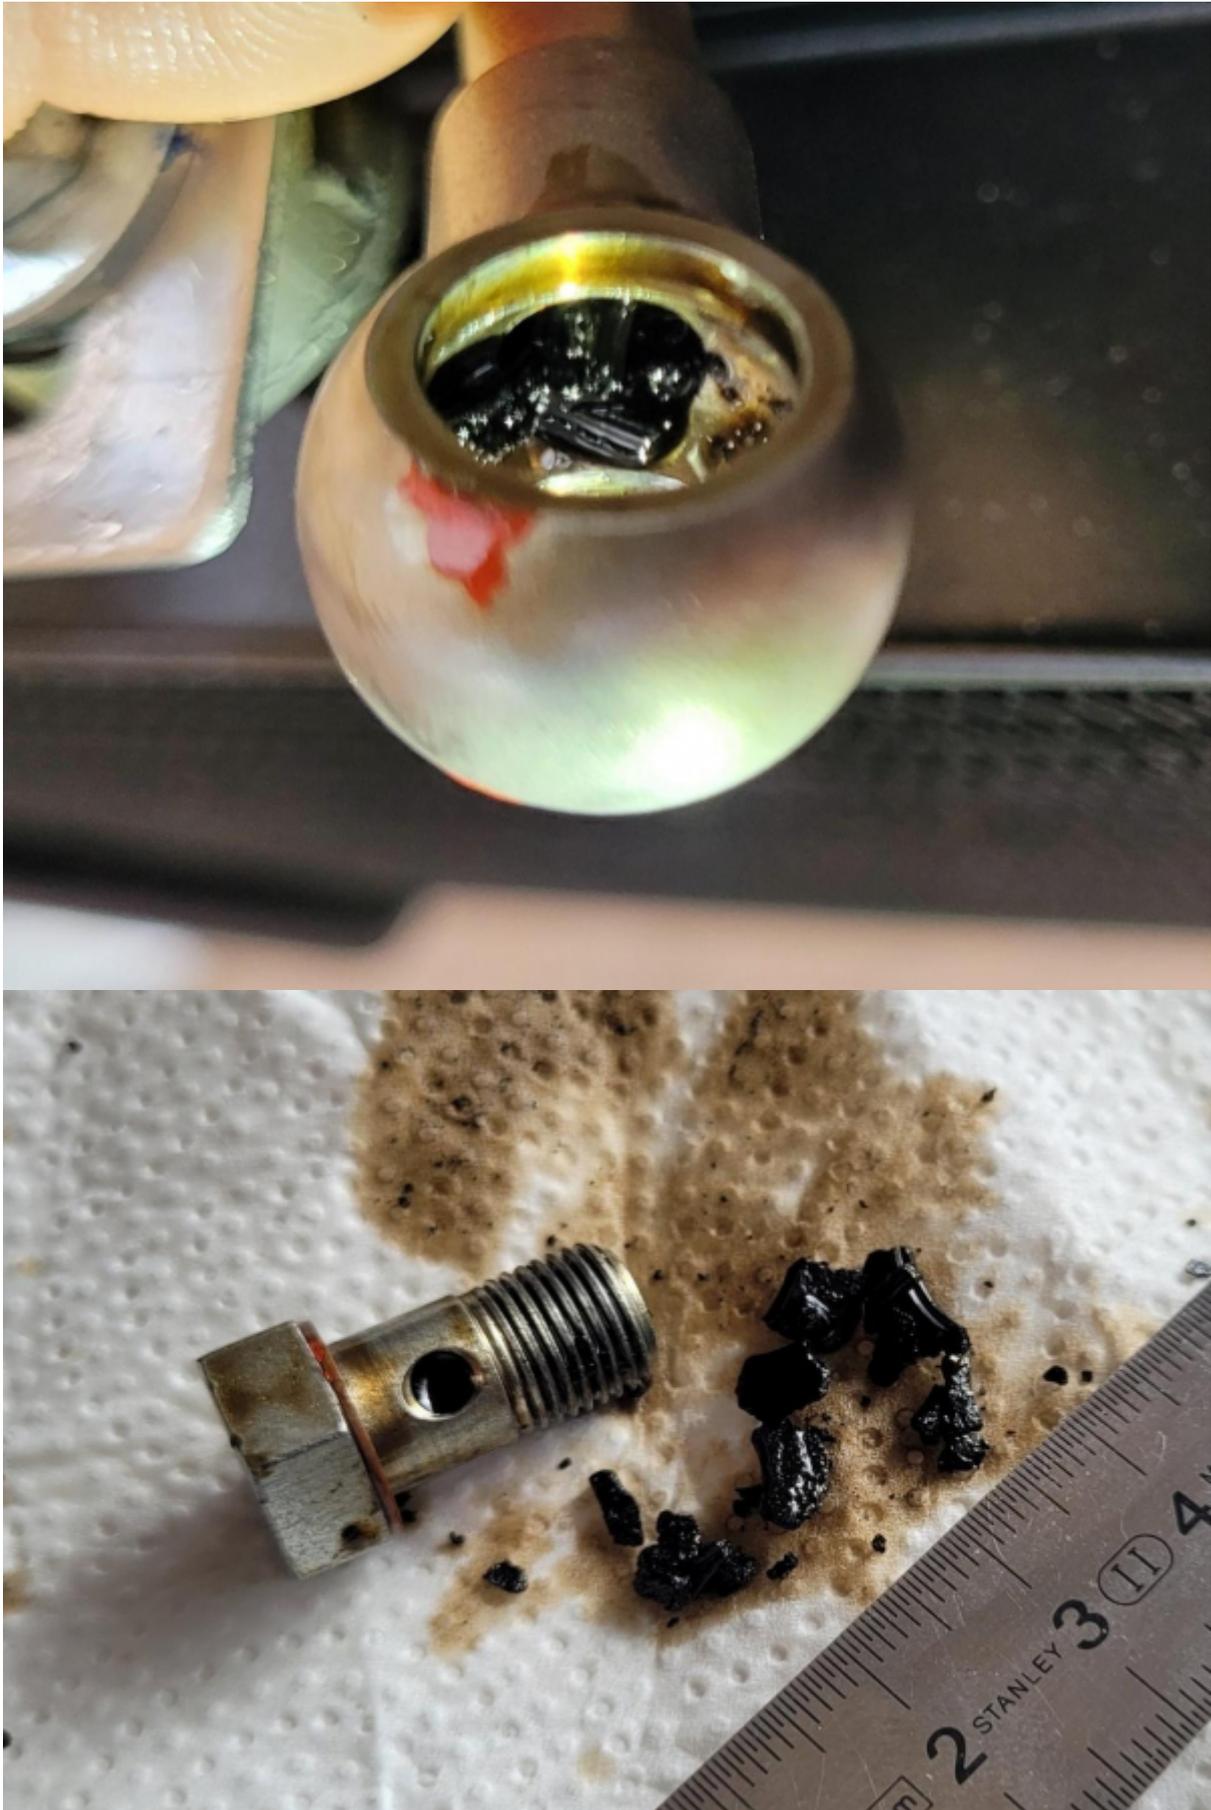
1)

- no leak was detected on the engine
- there was always oil pressure in flight
- the oil level on the dipstick is just below minimum

Of course, this was also the case here, which is why I was so surprised to find such lumps.

Unfortunately, the question could not be clearly answered, but it is reasonable to assume that the times of the cooling run were too short at some point.

However, it is quite clear that the „good outcome“ of the story is due to the fact that the banjo bolt in front of the oil pump was not yet completely blocked. The amount of oil that could still pass through here was apparently just under the amount that was pumped to the center section to lubricate the turbocharger. The quantity that was not returned caused the oil to overflow at the points where the turbocharger shaft was positioned. As a result, the oil was forced out on both sides of the turbo, some of which ended up in the exhaust and some in the airbox, causing the oil plume.

they are caused by coking of the engine oil on the shaft, mainly in the area of the bearing at the turbine wheel (the side that is driven by the exhaust gases). When the engine is running, the engine oil cannot coke here, as there is always a certain amount of cooling due to the lubrication process. If the oil is not pumped and the shaft is not yet cold enough, the oil that has come to rest boils away and forms nice lumps of carbon. These then eventually fall into the oil sump, are sucked towards the oil pump by the suction line and possibly clog the banjo bolt in front of the oil pump.

The moral of the story, don't shorten the cooling run!

This is another reason why I always recommend removing the oil reservoir and checking for carbon crumbs when changing the oil. Small black crumbs in the oil filter mat are another warning sign!

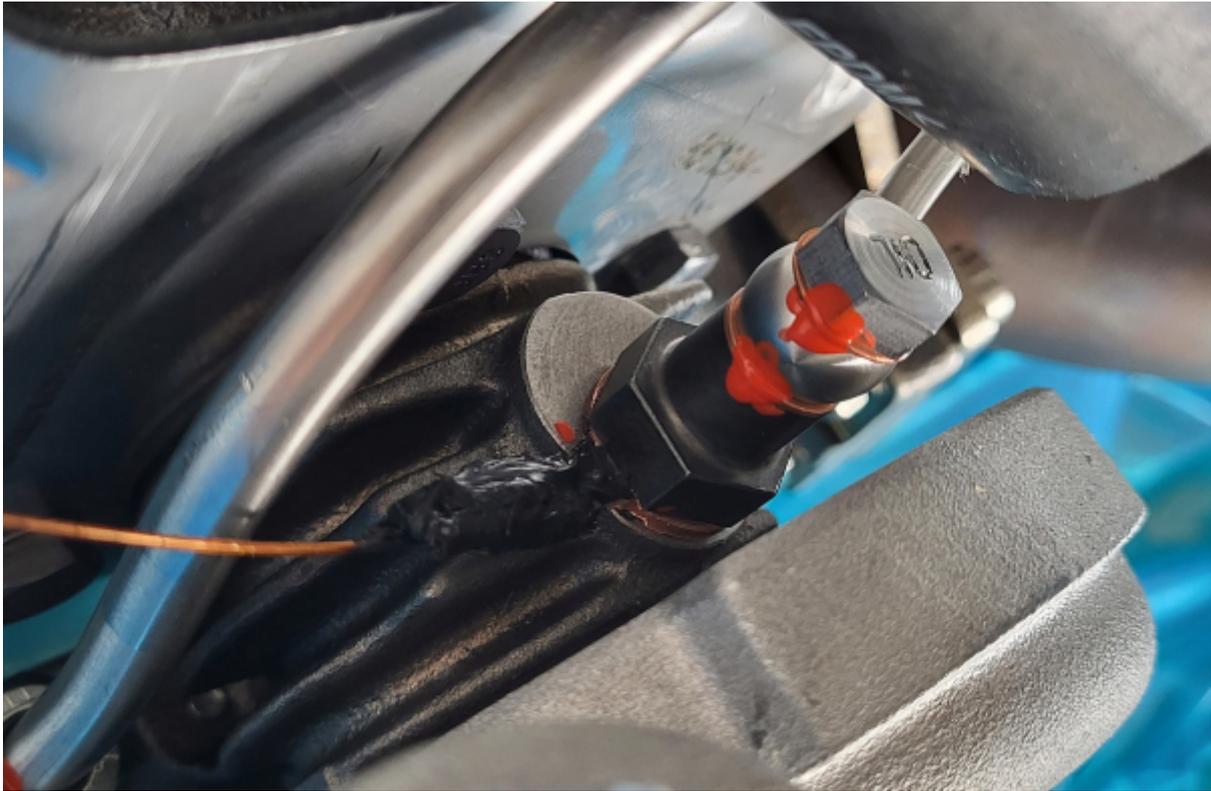
We fitted the sensor to the oil inlet of the center section of a Turbo-Dimona as a replacement for the copper seal that is fitted under the valve housing.

We had just 120°C in flight after 5 minutes of take-off power. After landing and the cooling run approx. 100°C .

The temperature rose to approx. 130°C after parking.

However, these are temperatures that do not lead to carbonization.

Consequently, carbon formation only takes place on the shaft in the area of the turbine wheel.

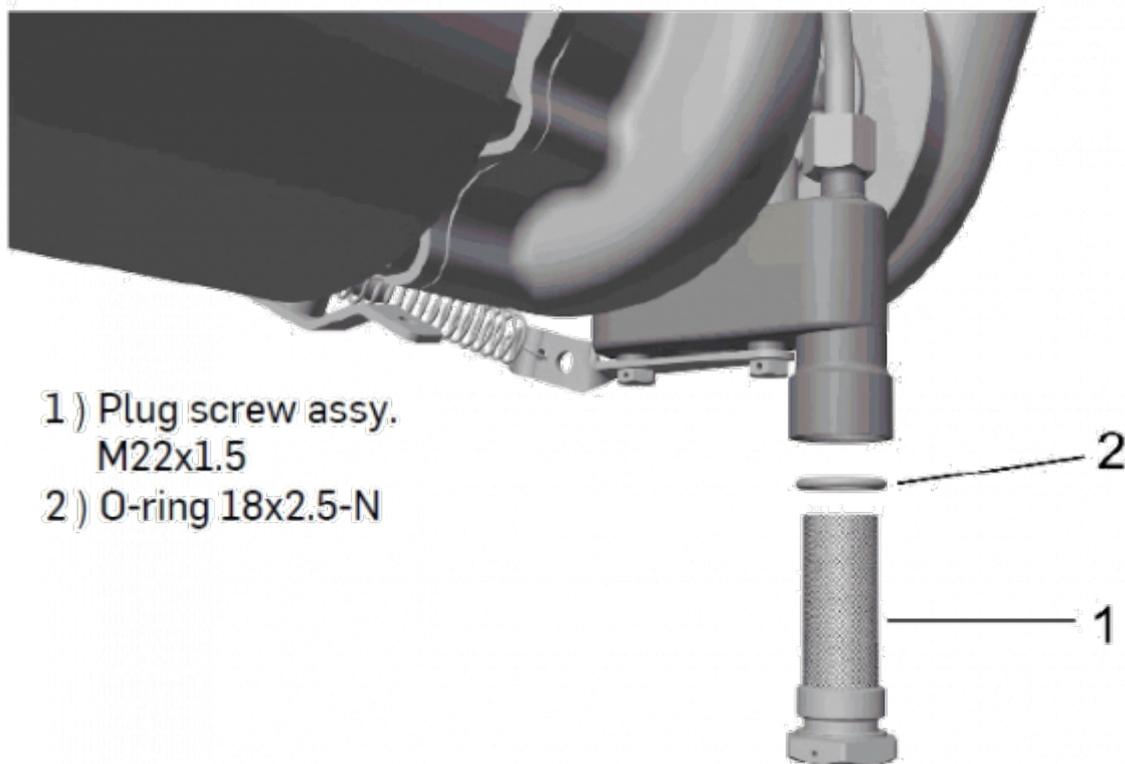
[SI-914-039](#) Introduction of a new oil sump assy for ROTAX Engine Type 914 (Series) from 20.02.2023

A strainer is integrated into the oil sump vessel here, which prevents carbon crumbs of one size from reaching the banjo bolt of the return line, which can clog it.

I recommend everyone to install this unfortunately not quite cheap part.
