# Leak at the cylinder base

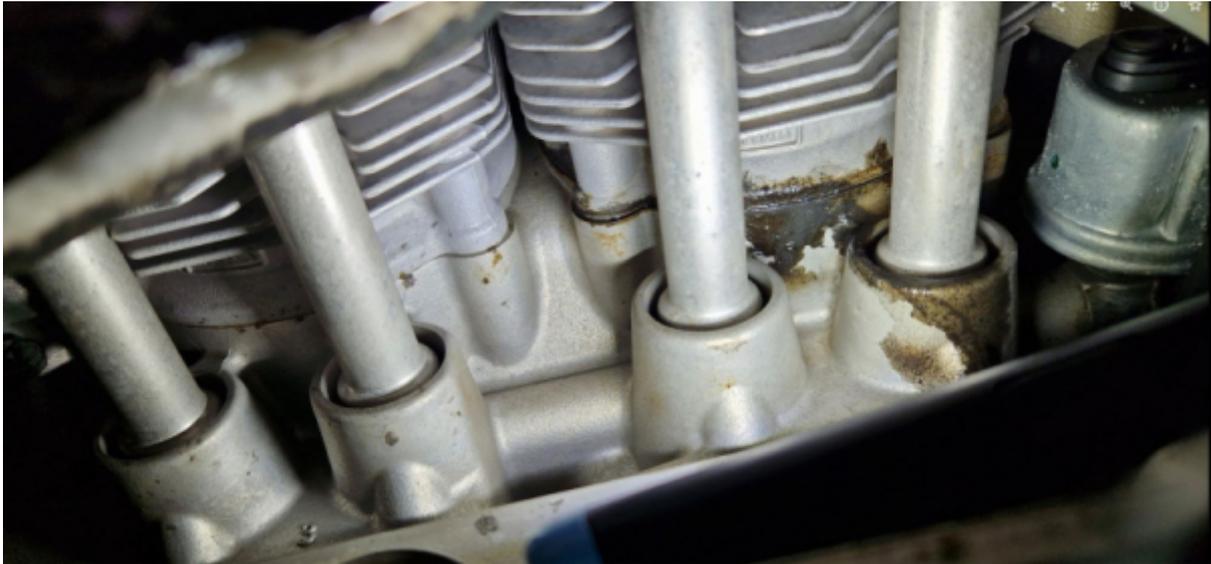
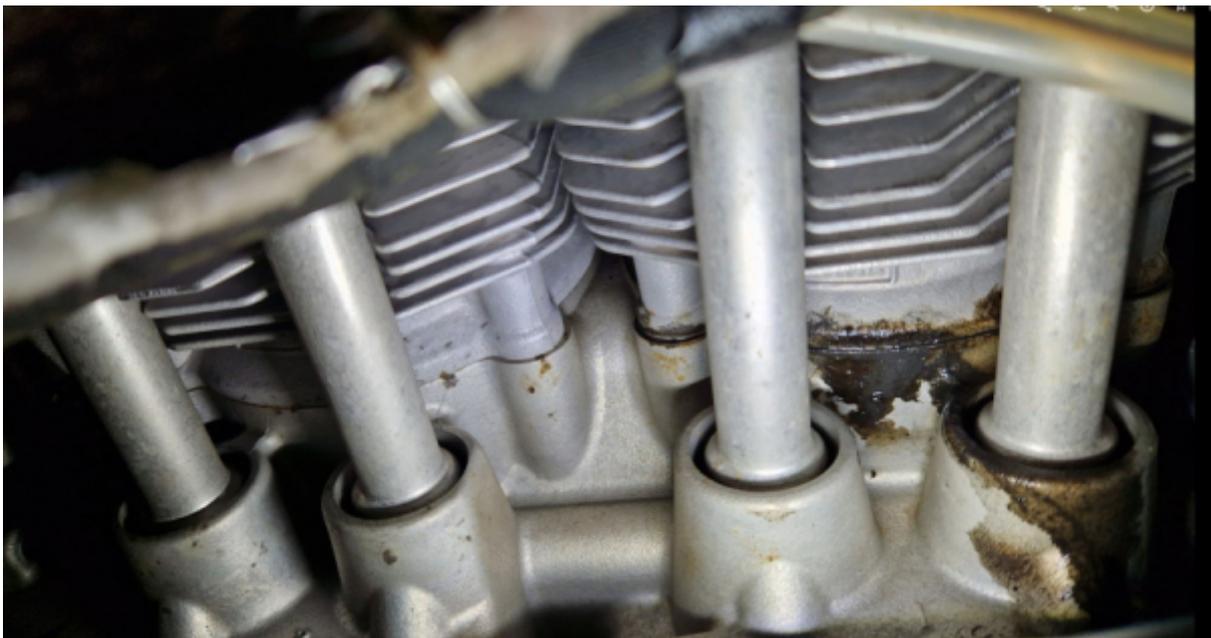
**Oil where it doesn't belong.<sup>1)</sup>**

Order and install the O-rings.

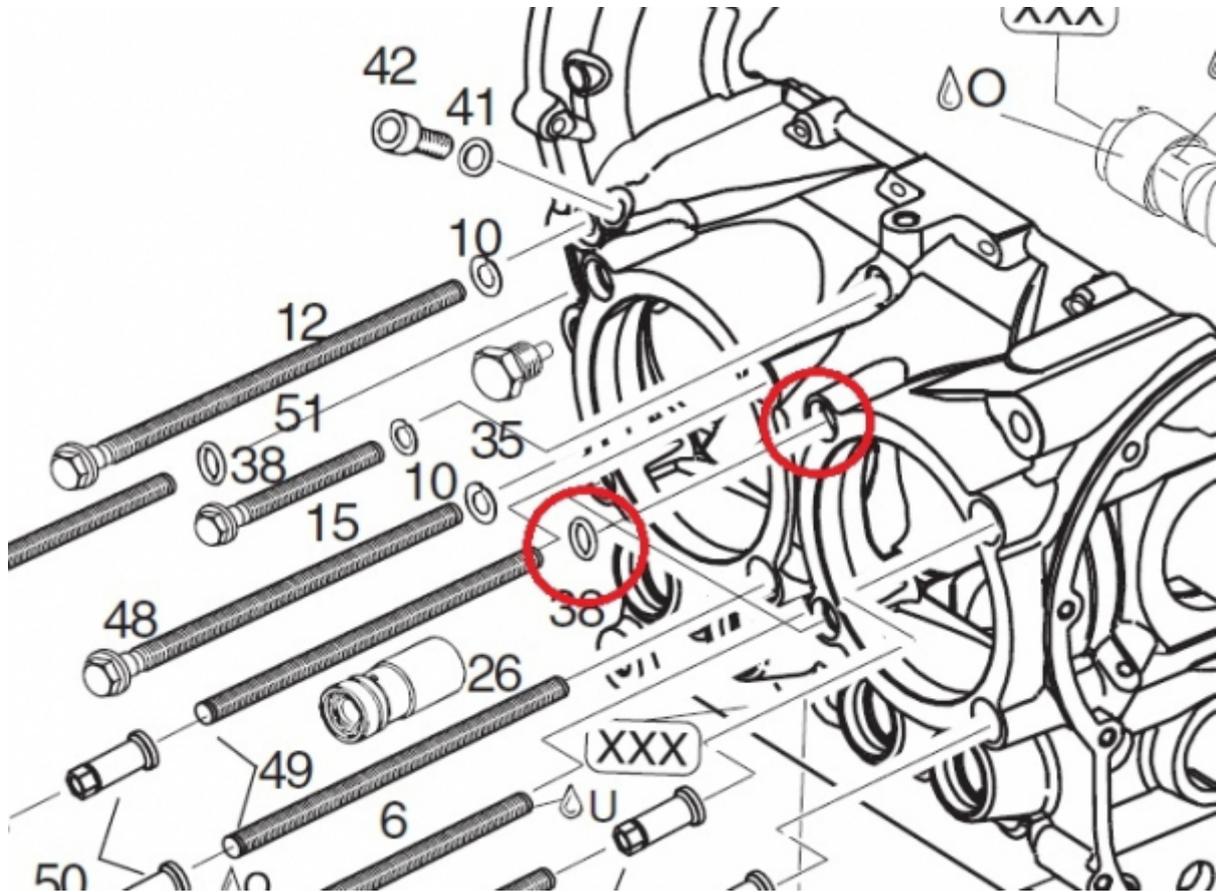
The inconspicuous part 38 is missing here.  
P/N 431570 O-RING 10.82 X 1.78

Quite simply: after a modification to the crankcase, no O-rings were installed here.

[Read in the SI-912 i-006 R1 / SI-912-019 R3 / SI-914-021 R3](#)

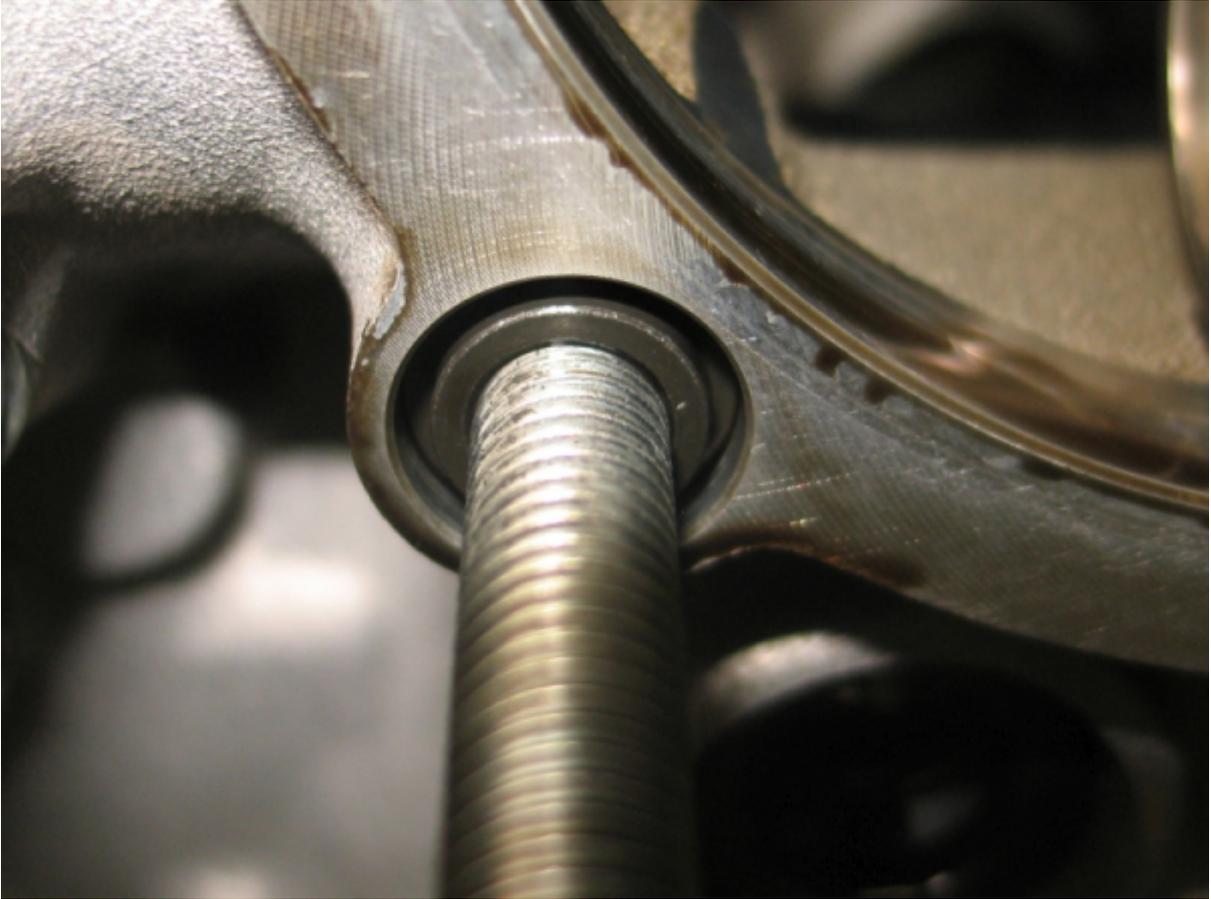
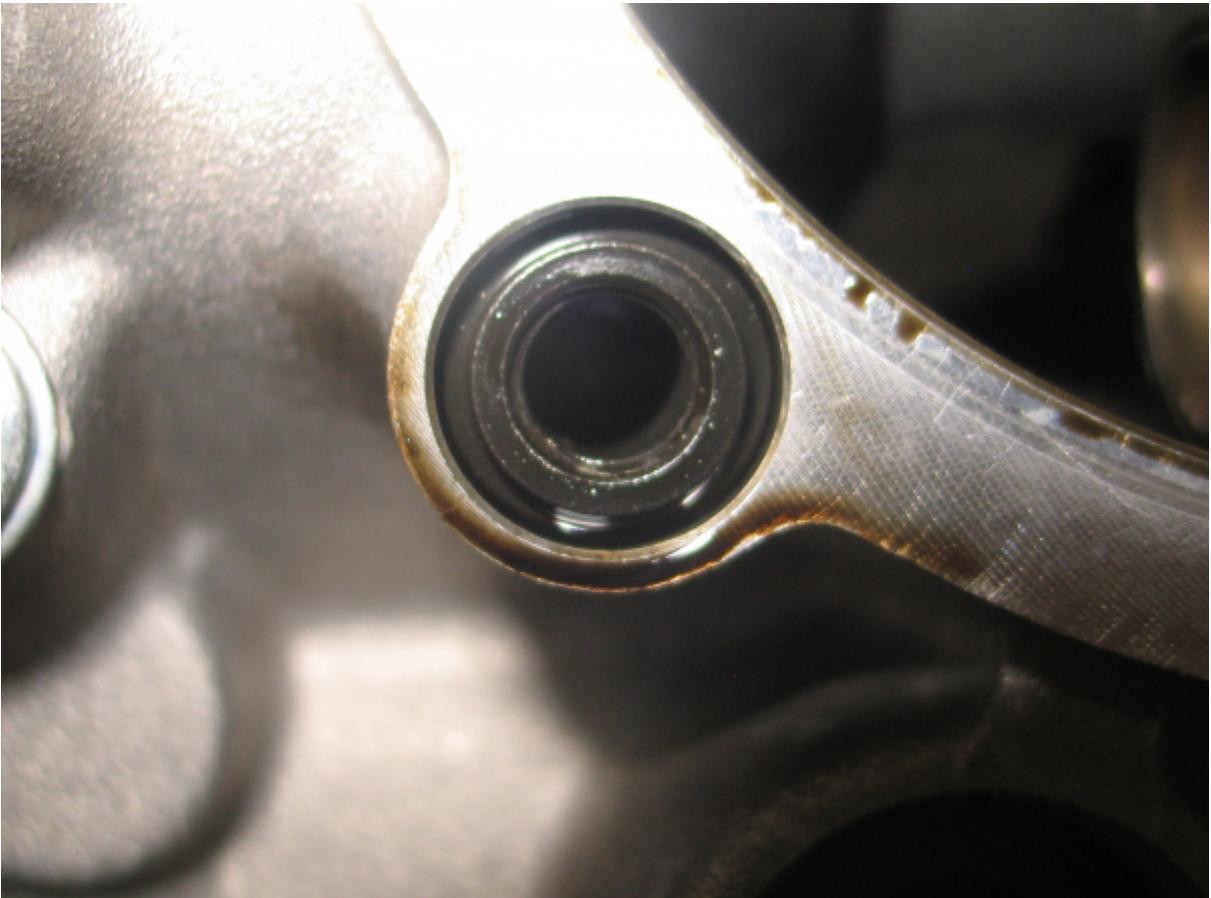
[After the cylinder has been removed, it looks like this:](#)
