# The check valve on the 914 turbocharger

... or why there is a pool of oil under the 914

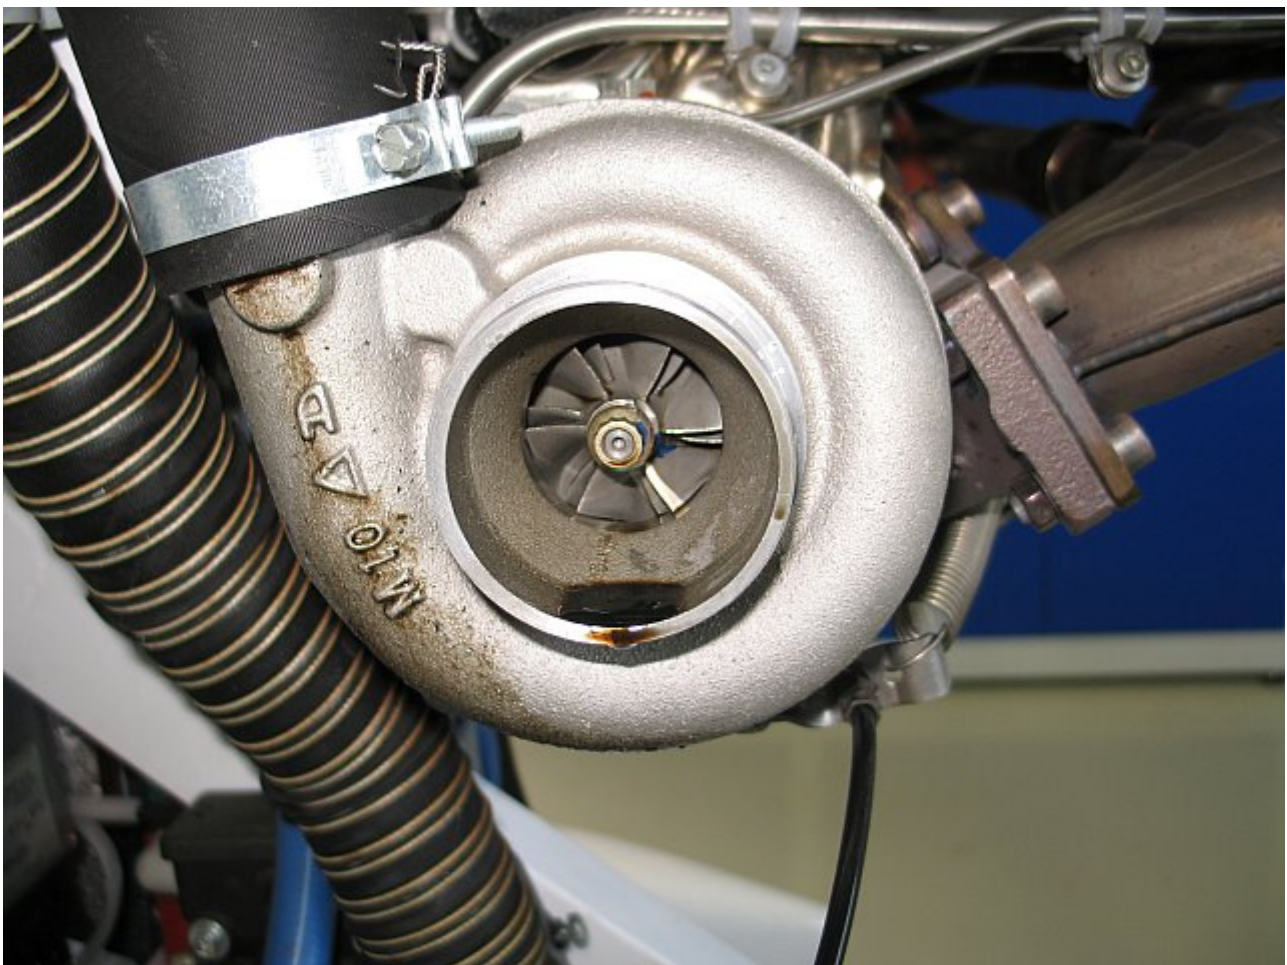
Now the hose is removed from the turbine housing and **you can see the following picture:**

A pool of oil that shouldn't be there is smiling at you in the turbocharger.

If the non-return valve in the valve housing is not tight, the oil sump will fill up and then the turbine and compressor housing will also fill up.

If this is also full, the oil continues to run into the exhaust and into the compressor housing inlet. Here you can see the oil loss when oil drips from the intake hose.

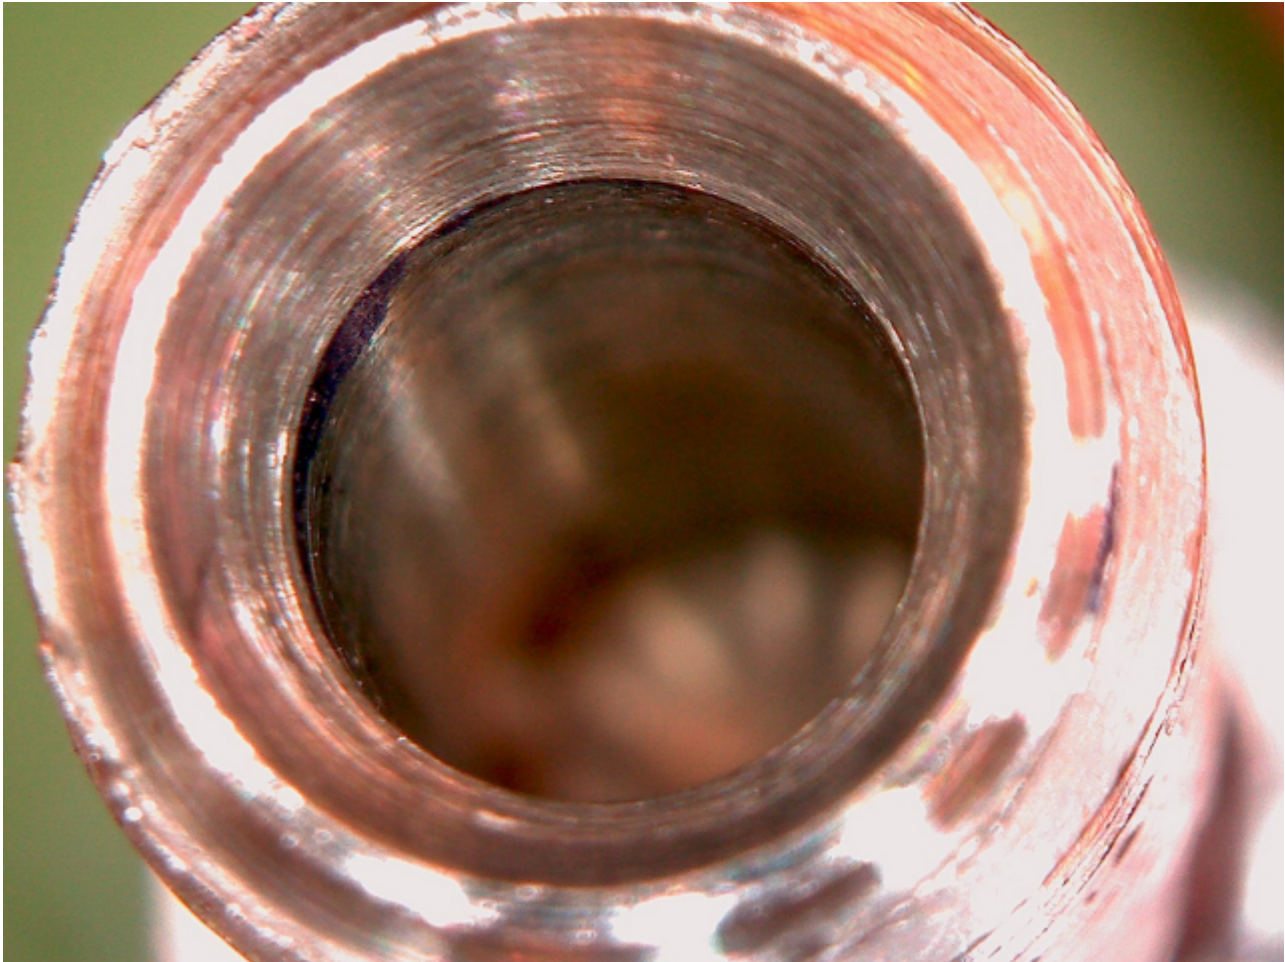
Unfortunately, the valve seat is not always designed precisely enough to be considered a valve seat, as the following image illustrates.

The image shows the conical valve seat in the banjo bolt. You can imagine that a leak is pre-programmed here.

However, I must point out that the picture is from an older version. The banjo bolts are now made of stainless steel and generally look better.

1. During the warranty period, get on your contractual partner's nerves until they have rectified the problem
  2. Fit a new banjo bolt (or have one fitted)
  3. rework the valve seat
1. is probably the most time-consuming and annoying method, as you have to reconcile deadlines
  2. very successful with a „good“ banjo bolt
  3. **nothing for beginners.**

Place the banjo bolt with the bolt head on a stable surface (anvil, vice) and place the ball on the valve

Then place a cloth over it to keep the ball in place.

Now hit the ball with a 200g hammer with a targeted and balanced blow.
