The turbo switch on the 914

... or what is the mystical devil thing actually there for?

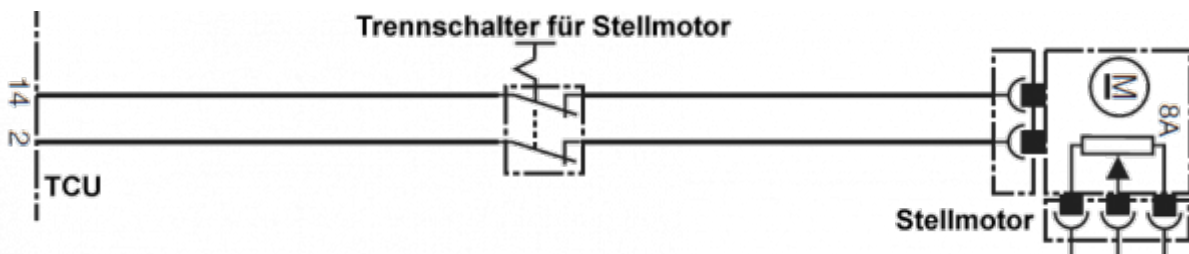
Disconnect switch for servomotor

The isolating switch is used to briefly switch off the servomotor if the boost pressure regulator oscillates.

A stable operating state should then be established after a short control time.

The circuit diagram now shows exactly what the switch actually switches. The technical background is not explained in the aircraft operating manuals, but only a dubious procedure is specified.

The power supply to the servo that actuates the wastegate flap in the turbocharger is interrupted. This means that the flap does not move any more after the switch is pressed. Now it depends on how far the flap is closed and how much throttle is applied. If the flap is almost closed and the power setting is high, this can lead to overboost (more than 1550 mbar airbox pressure), which may cause the crankshaft to twist.

A very clear recommendation is to seal the switch and include its inspection in the checklist.

**If the seal is damaged, do not take the flight.
read out the operating parameters of the TCU
and check for an overboost.**

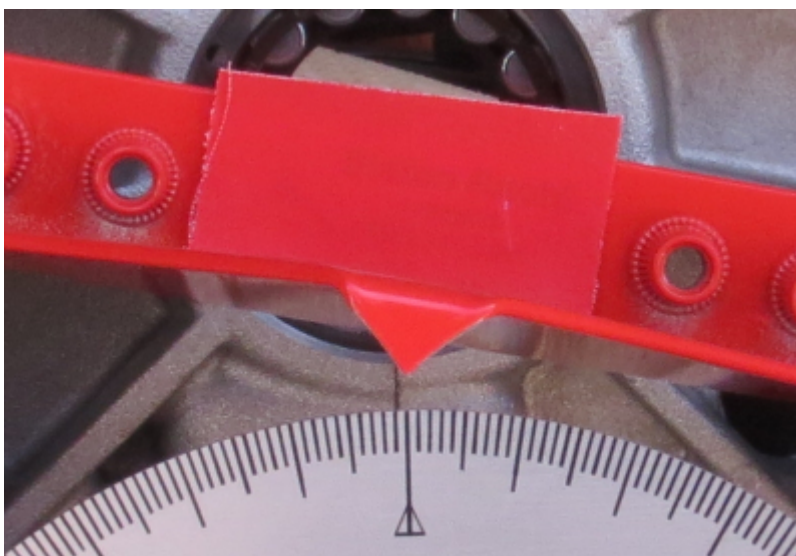
Piston turned to the piston stopper at cylinder 1 and the degree disk set to 0°.

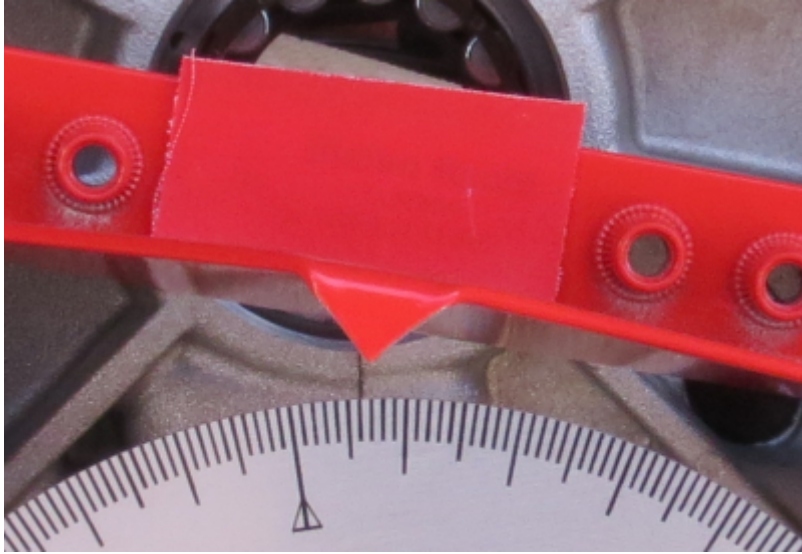
Turn the piston to the piston stopper at cylinder 2 and read the position on the degree disk.

Here you can clearly see that the crankshaft between the two measured cylinders is twisted by approx. 6° and needs to be replaced.
