# The transition holes

.... That's why I'm only reporting here on my experiences with modifying the Bing's on a 912 ULS with 100 hp.

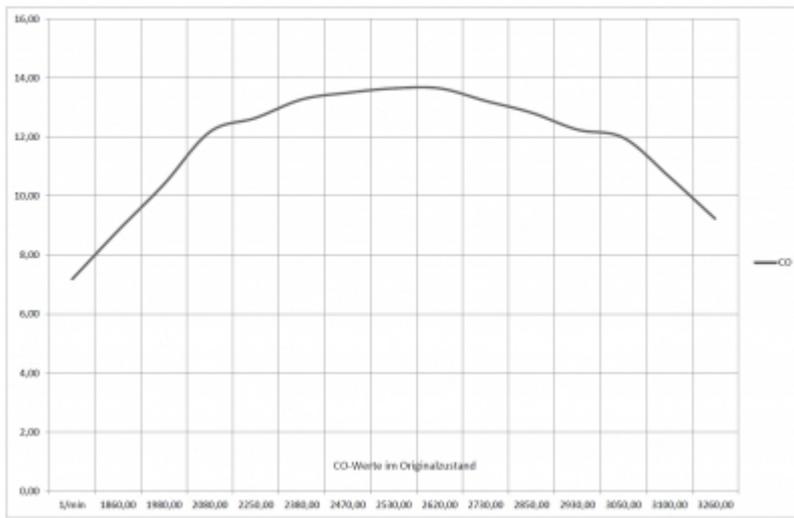
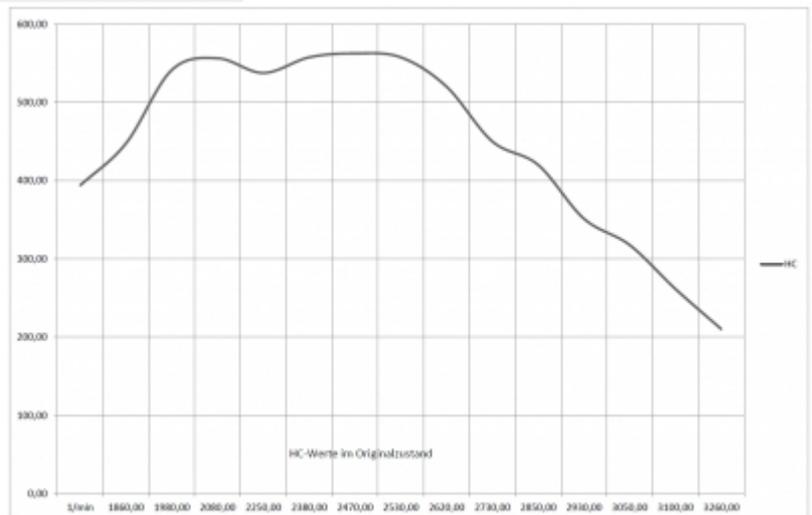
This is why we have the following exhaust gas values (values determined on the test bench with overhauled carburetors) for the Bing's in their original condition (left CO - right HC):

At almost 14% CO and 550 ppm HC, the engine is already running very close to the „stall limit“.

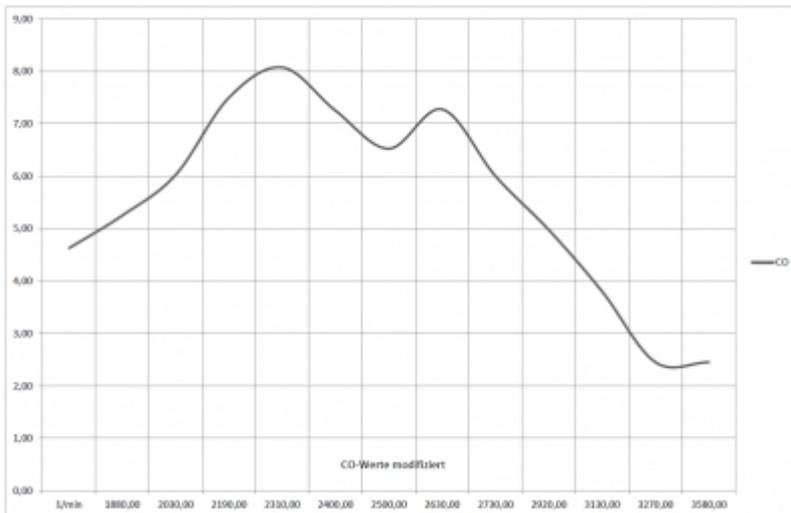
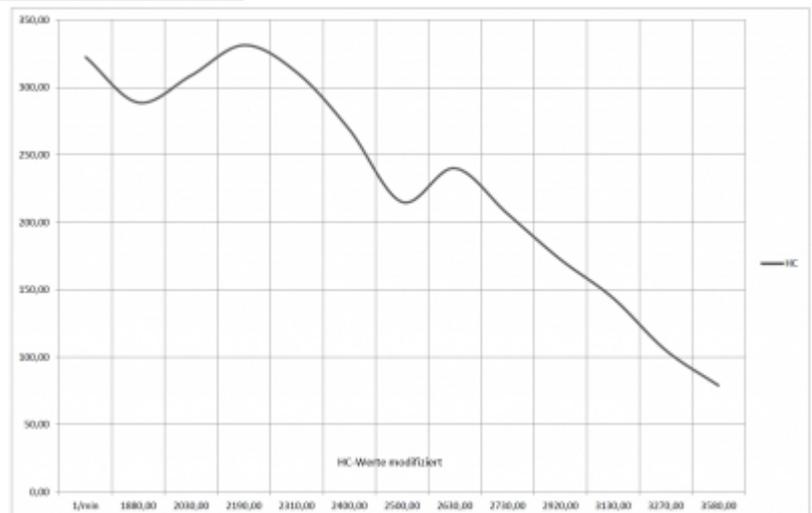
Subsequent test runs with extensive exhaust gas measurements and also tests with sudden throttling in every operating state then resulted in the following pictures:

... looks great, I thought to myself and looked for a test pilot ....

Since I was able to gain some experience with carburetors during my almost 30 years as a motorcycle mechanic, I have now sealed the transition bores on a set of used Bing's.

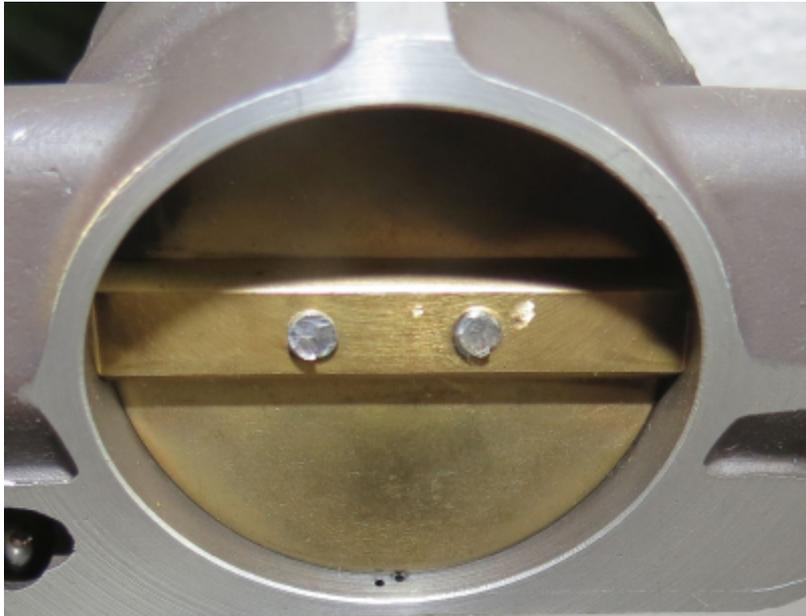
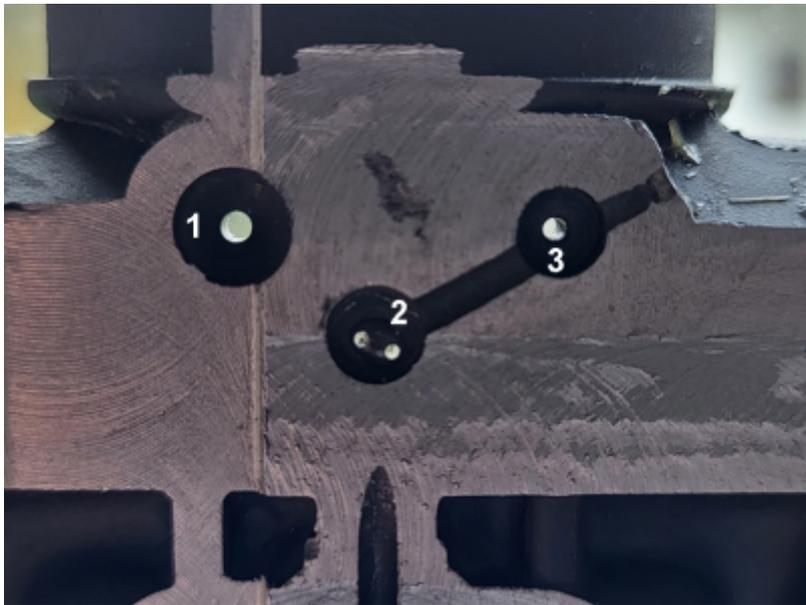
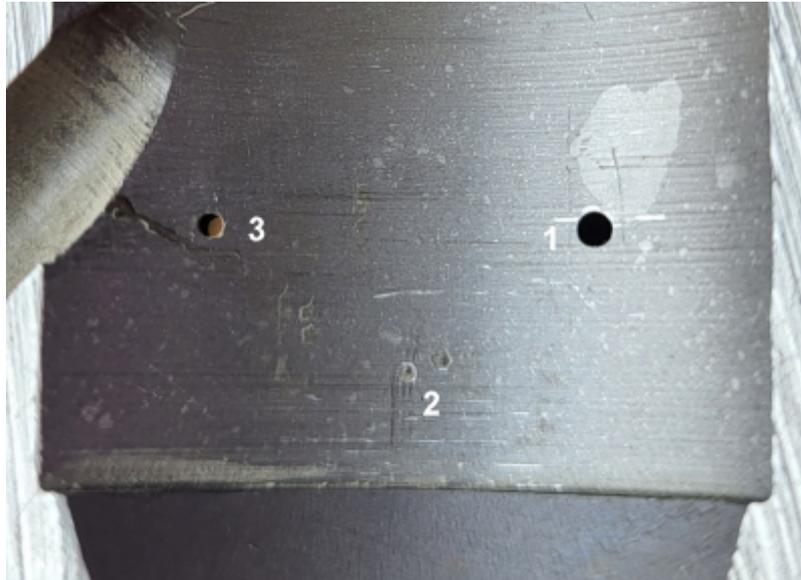
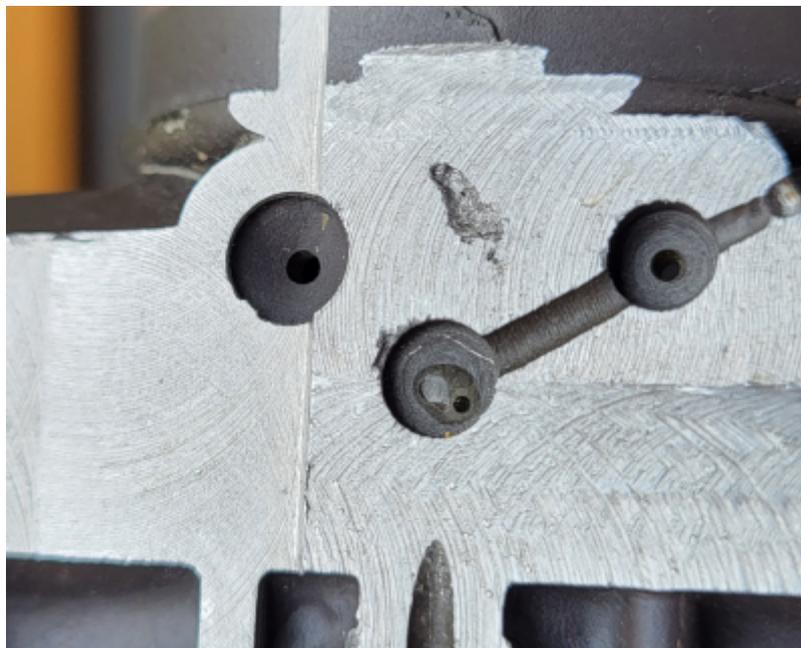
### Picture story

**1**=Synchronization connection **2**=Transition holes **3**=Hole for idle mixture adjustment screw and outlet of the idle mixture in operation

- removed the float chamber from the carburetors
- removed the idle jets and mixture screws
- flooded the holes of the idle jets with brake cleaner and blew them out – so that the idle system is dry and grease-free –
- a little [2K-Stabilit Express](#) <sup>1)</sup>
- and glue the transition holes.
- When gluing, make sure that not too much adhesive gets into the transition holes, otherwise the channel in the carburetor will be closed. The carburetor can then only be saved with considerable effort.
- The excess glue is simply cut off with a scalpel in the Venturi tube with the throttle valve open while it is still not fully cured.
