the leakage hole on the igniter housing

... mostly well hidden holes and their meaning

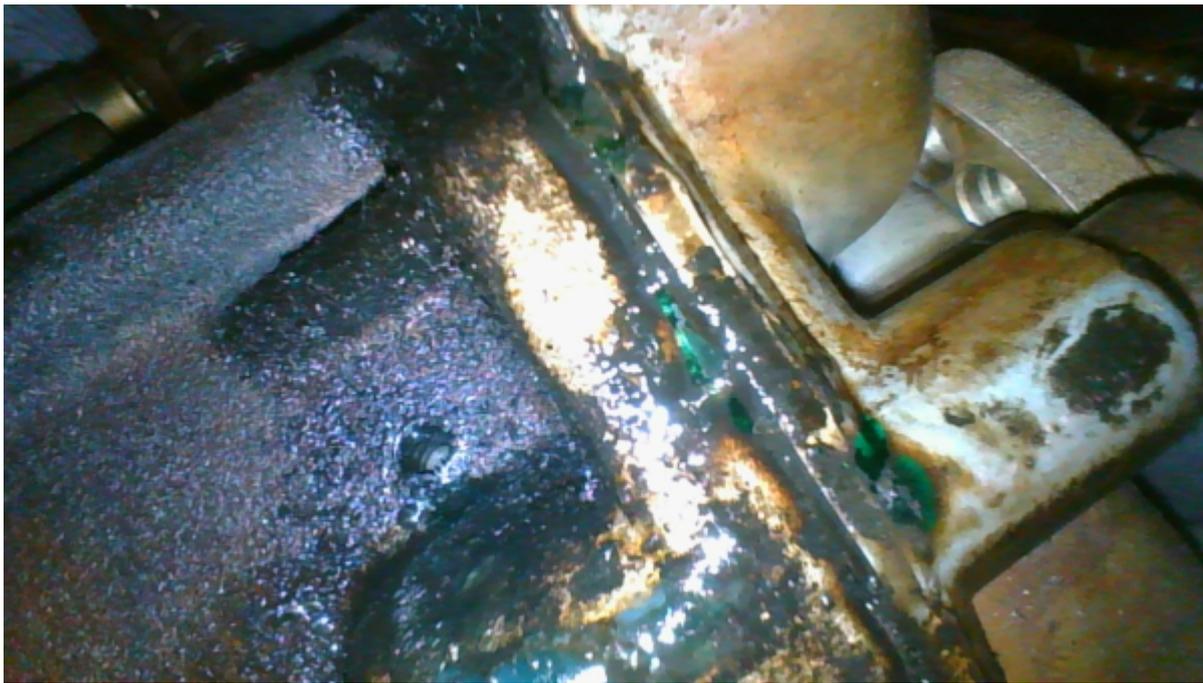
Cooling water escaping from the leakage hole

If coolant is leaking here, the mechanical seal is defective.

These are two ceramic rings that slide against each other under spring load and thus keep the coolant in the cooling circuit.

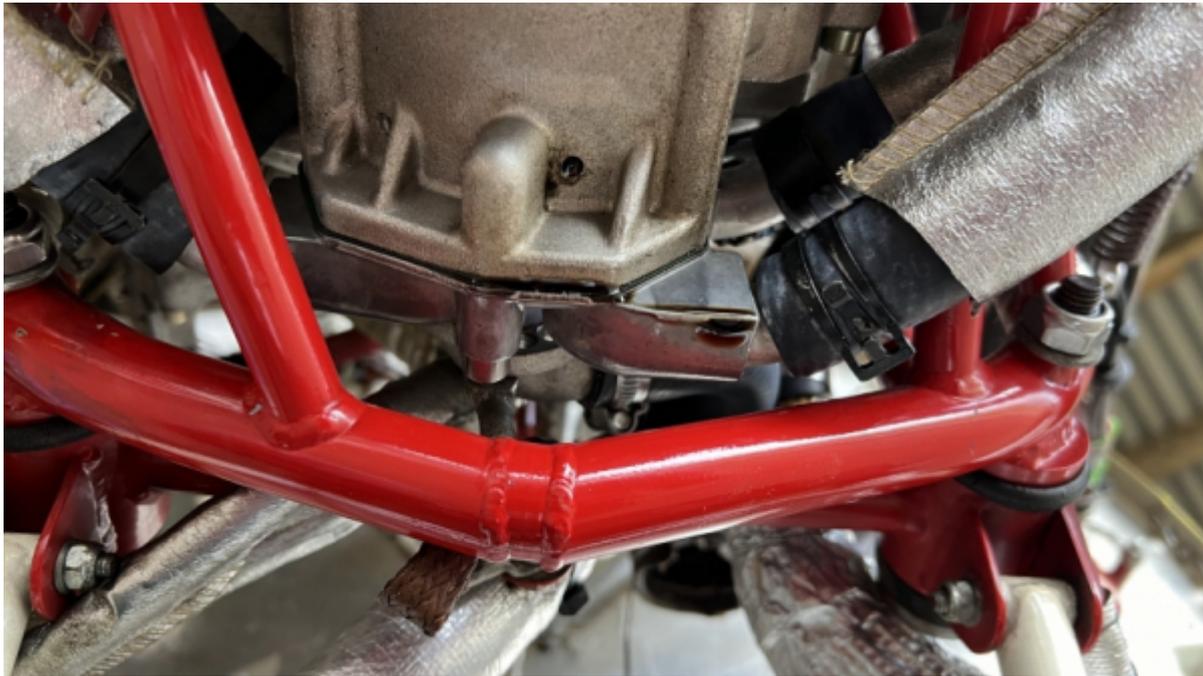
Oil leaking from the leakage hole

If you notice oil leaking from the leakage hole, the shaft seal ring, which is supposed to seal the engine oil at the water pump shaft, is defective.

In both cases, the igniter housing must be dismantled and repaired by a specialist (Rotax-trained personnel who also have the necessary tools). As an alternative, [FRANZ Aircraft Engines Vertrieb GmbH](#) offers a repair service, also with EASA Form 1 release certificate, for an igniter housing sent in.
