## Replacing the float needle valve seat bushing

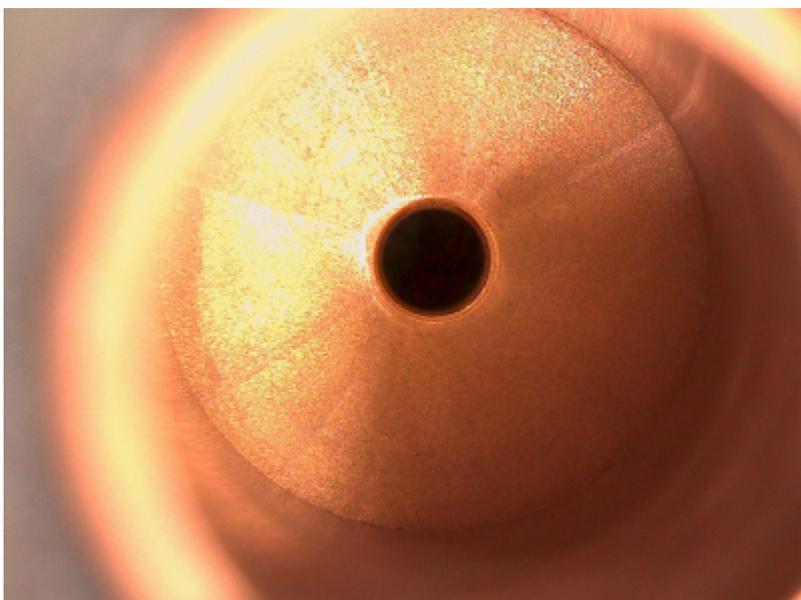
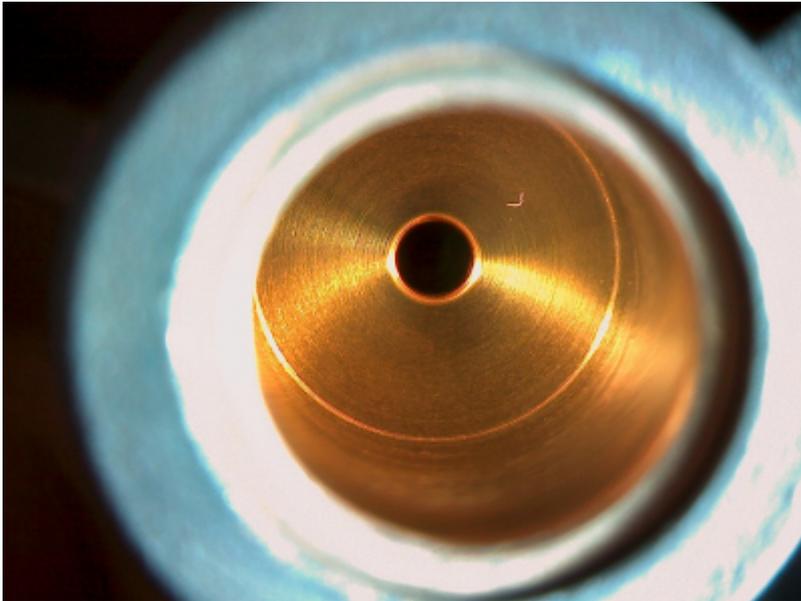
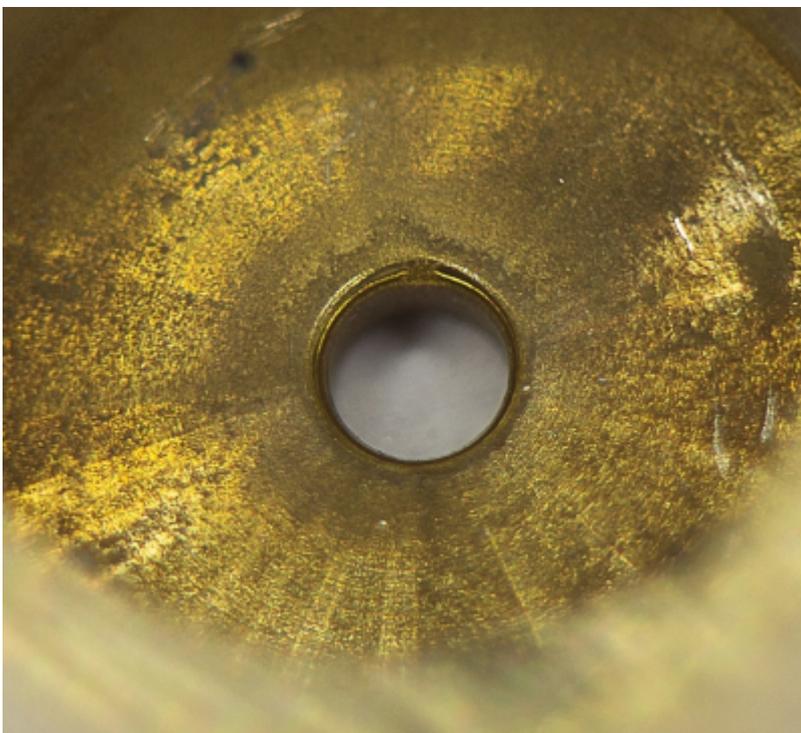
.... and here it comes: Carburetor checked 3 times and constantly the same game with the overflowing carburetors <sup>1)</sup>.

Float needle valve seats under the microscope  
- the first picture was taken after 120 operating hours  
The third picture is by © Steffen E. and is a very clear example as a supplement to his post in the UL forum.

But now you can resort to a repair method not approved by Rotax. **Replace the valve seat bushings.**

You can order them [--here--](#) and replace them relatively easily with the [--self-build tool--](#).

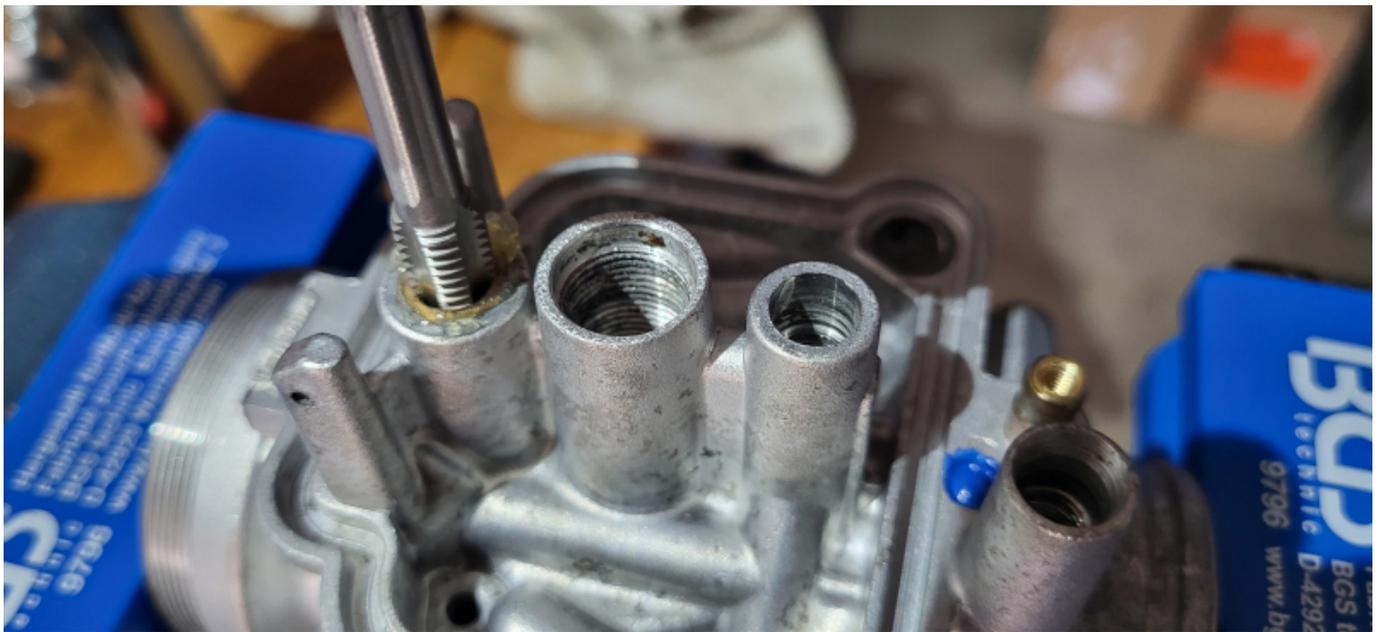
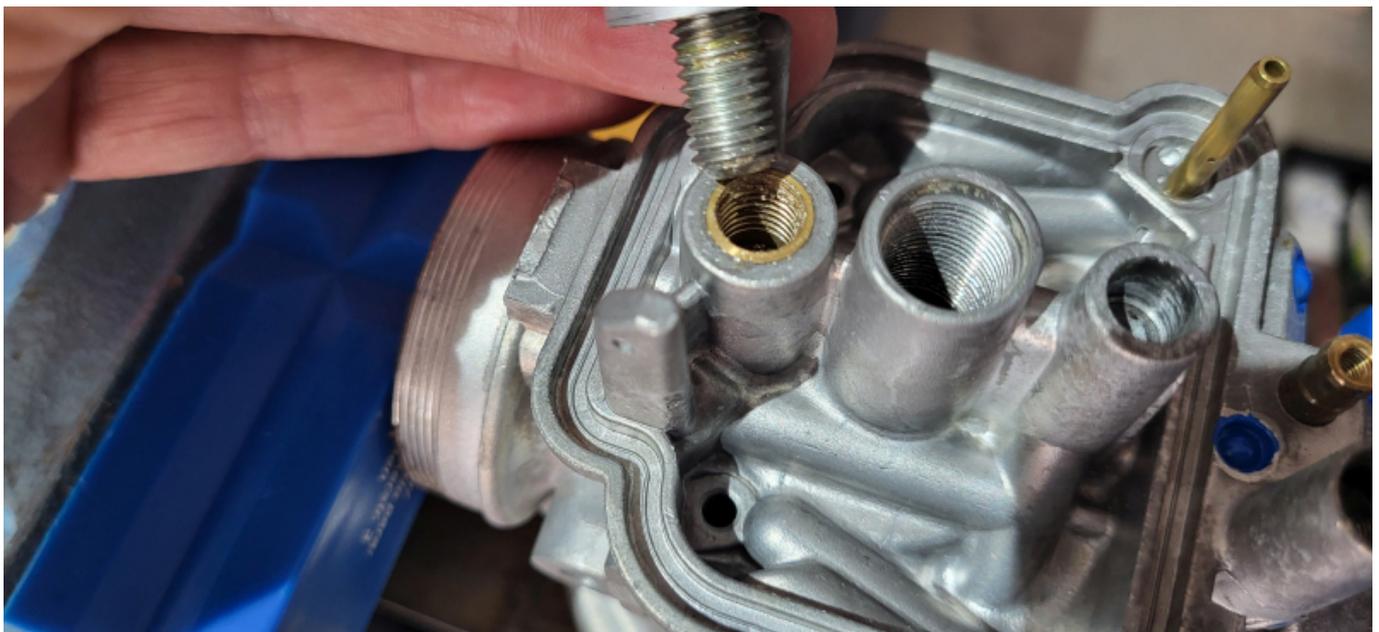
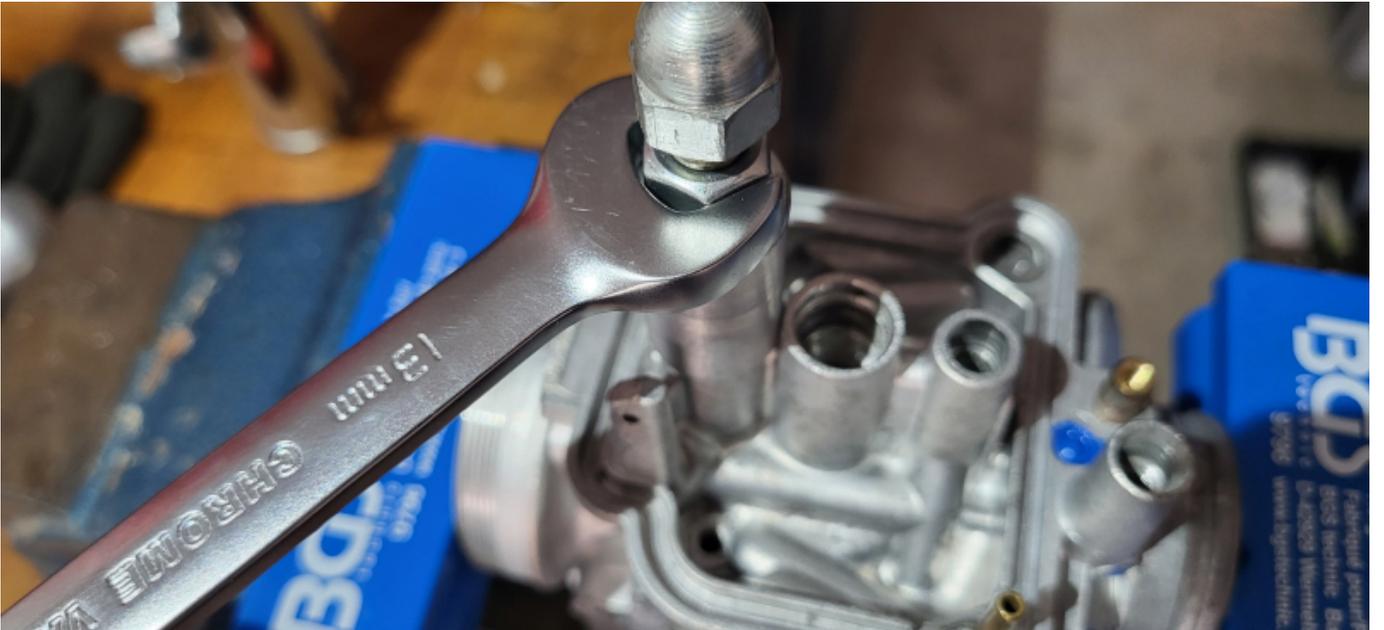
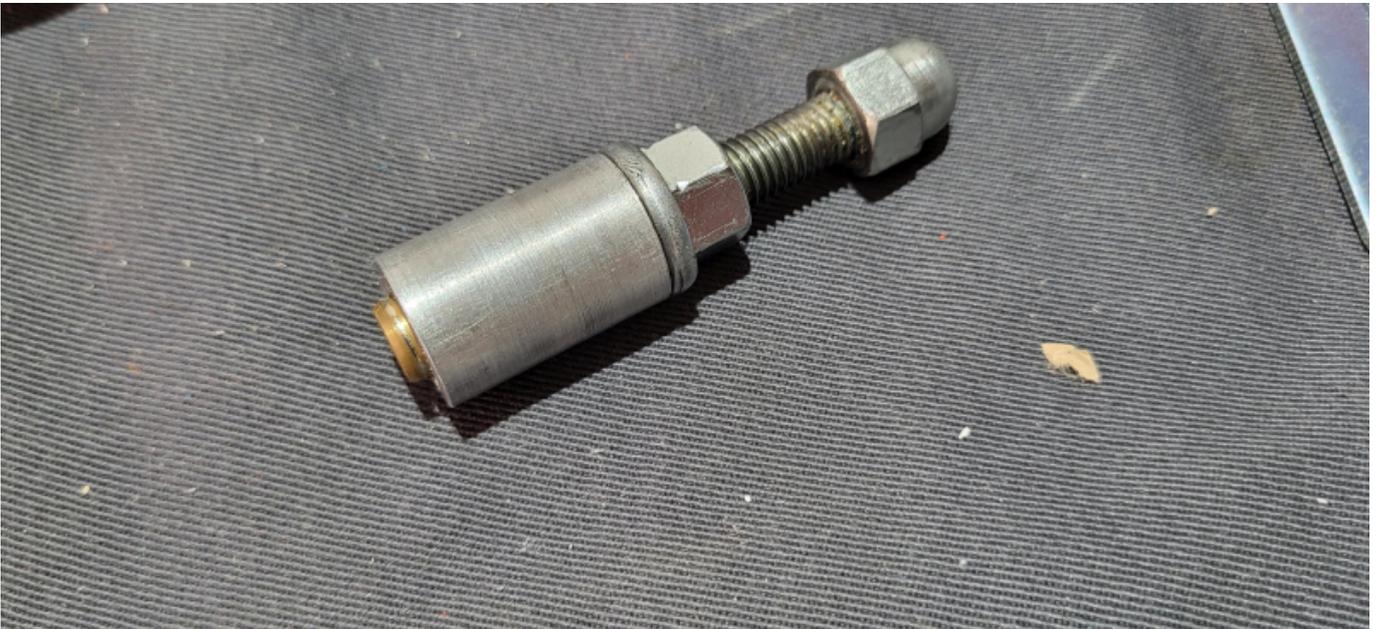
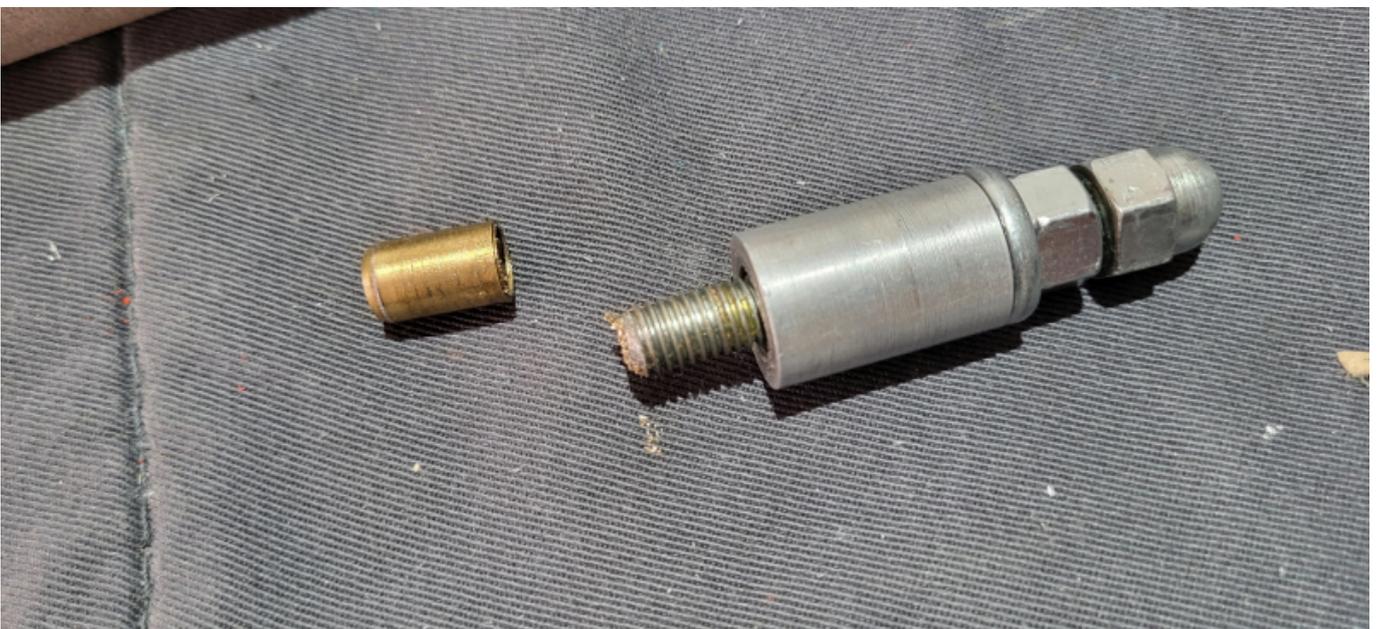
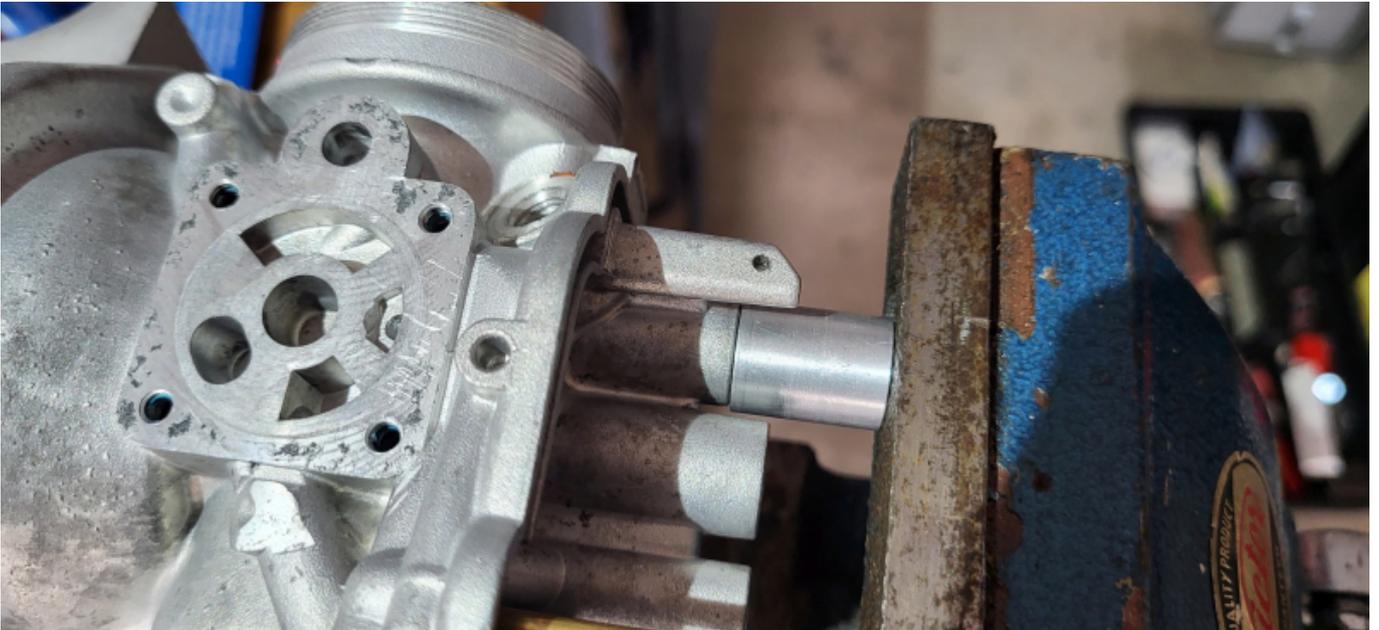
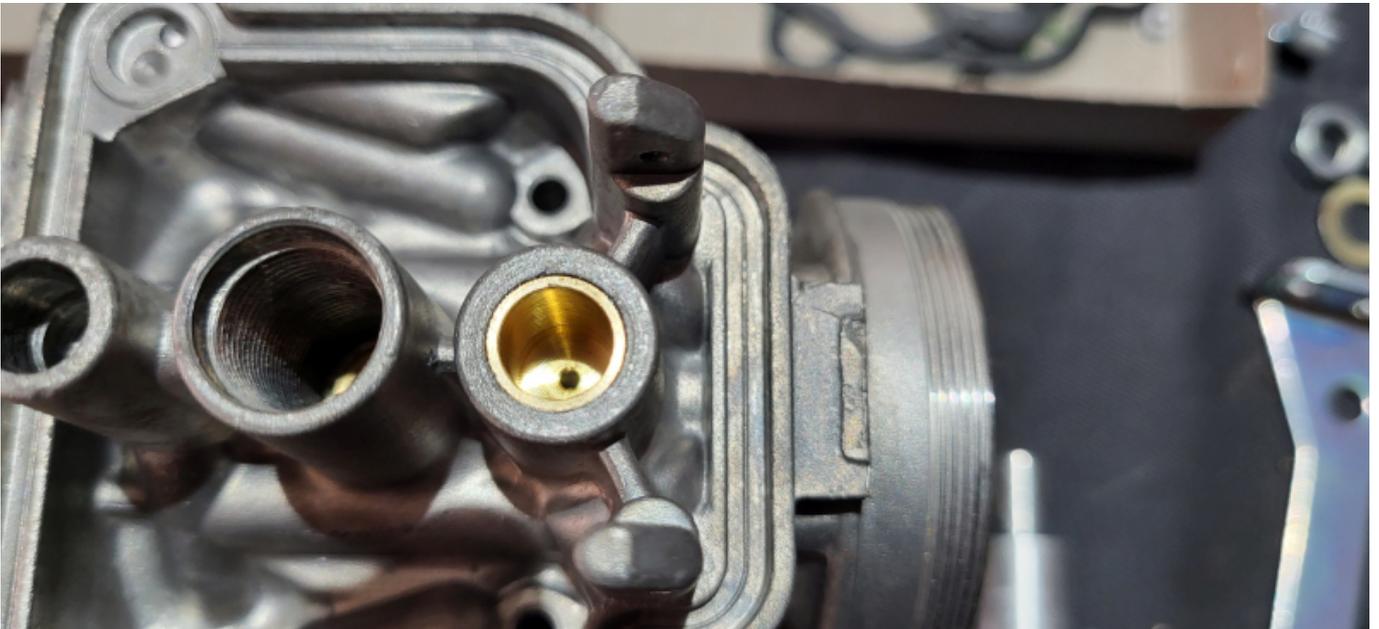
- Remove the overflowing carburetor and disassemble it completely,
- use an M8 tap to cut a thread in the bushing, to do this, grease the front of the tap properly to catch the chips
- Screw the screw of the tool with the nut and the extraction bushing into the valve seat and pull the valve seat bushing into the tool
- flush the fuel inlet with brake cleaner, blow it out and check for swarf
- sparingly wet the outside of the new valve seat bushing with Loctite 221 or 243
  - Loctite is used as a lubricant and for sealing
- Press in / hammer in the bushing with the insertion tool
- Install the float and float needle valve
- Adjust the float level with --Gauge--
- Complete and install the carburetor and synchronize the carburetors
