# the hoses of the float chamber ventilation

... on the 914 and their pitfalls.

## On the Rotax 914 it looks like this:

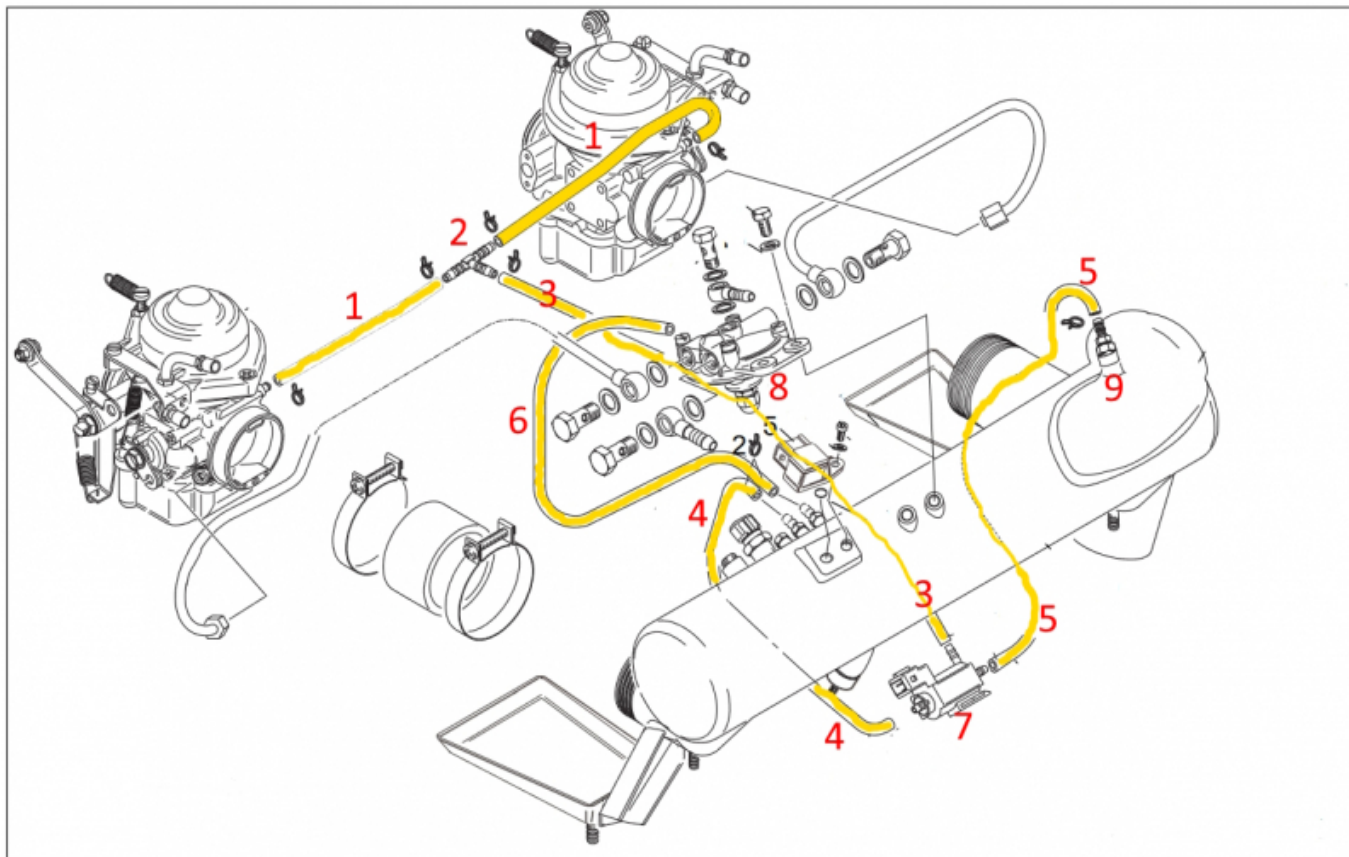
A hose(1) is fitted to each float chamber ventilation, which leads via a T-piece(2) into the individual hose(3) to the 3-way valve(7). If the airbox pressure is below 1280 mbar, the hose(4) leads from the 3-way valve to the middle of the airbox.

If the airbox pressure now rises above 1280 mbar, the 3-way valve switches over. As a result, the pressure for the float chamber ventilation is now removed via the hose(5) from a pitot tube(9) in the air flow of the air pressed into the airbox by the turbocharger.

Due to the position, design and setting of the pitot tube, the pressure in the float chamber is increased by 10 mbar. This means significant greasing at a power setting of 115%, i.e. starting power.

We also have the hose (6) that leads from the center of the airbox to the fuel pressure regulator. The fuel pressure regulator regulates the fuel pressure to 250 mbar via the airbox pressure.

## **Crack in hoses 1, 3 and 4**

## **Crack in the hose 5**

## **Crack in the hose 6**

1)  
the picture could be prettier

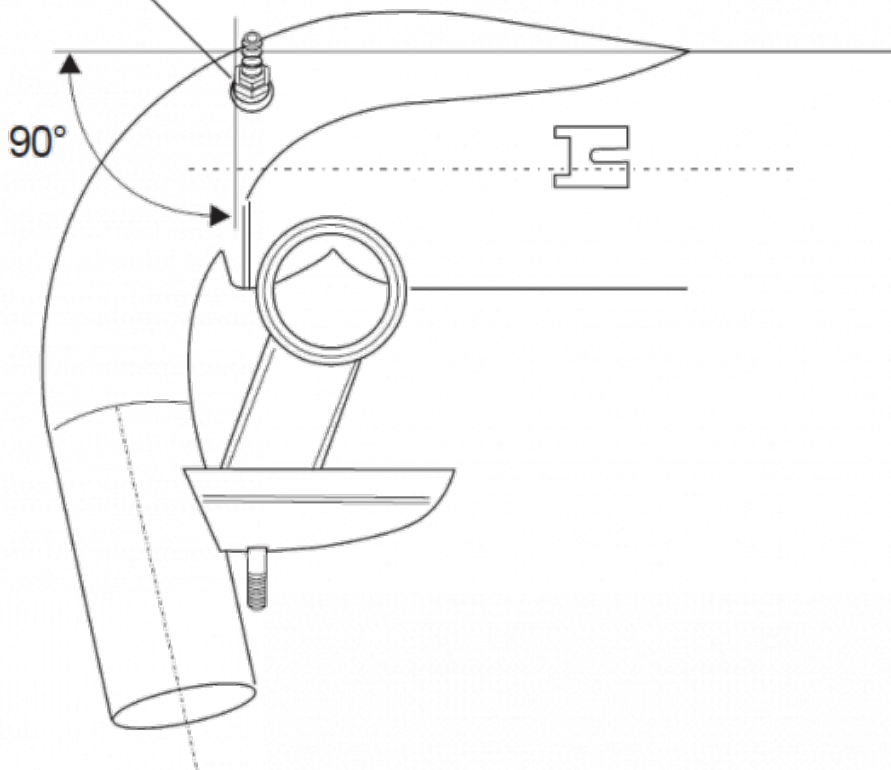
### Position of the enrichment jet: counter sinking on the hexagon

The pitot tube has a hole that is directed into the airflow that is fed from the turbocharger to the airbox.

Incorrect adjustment can lead to engine damage due to leaning.  
If the pitot tube is twisted, there is a basic setting as shown in the following illustration.

An exact setting is only possible on the engine test bench and is carried out after a repair during the test run.

This requires an exhaust gas measurement at starting power.

The lock nut of the pitot tube is marked in color with locking paint.
