... always black spark plugs

... or why the spark plug pattern on a Rotax carburetor engine is usually a fata morgana...

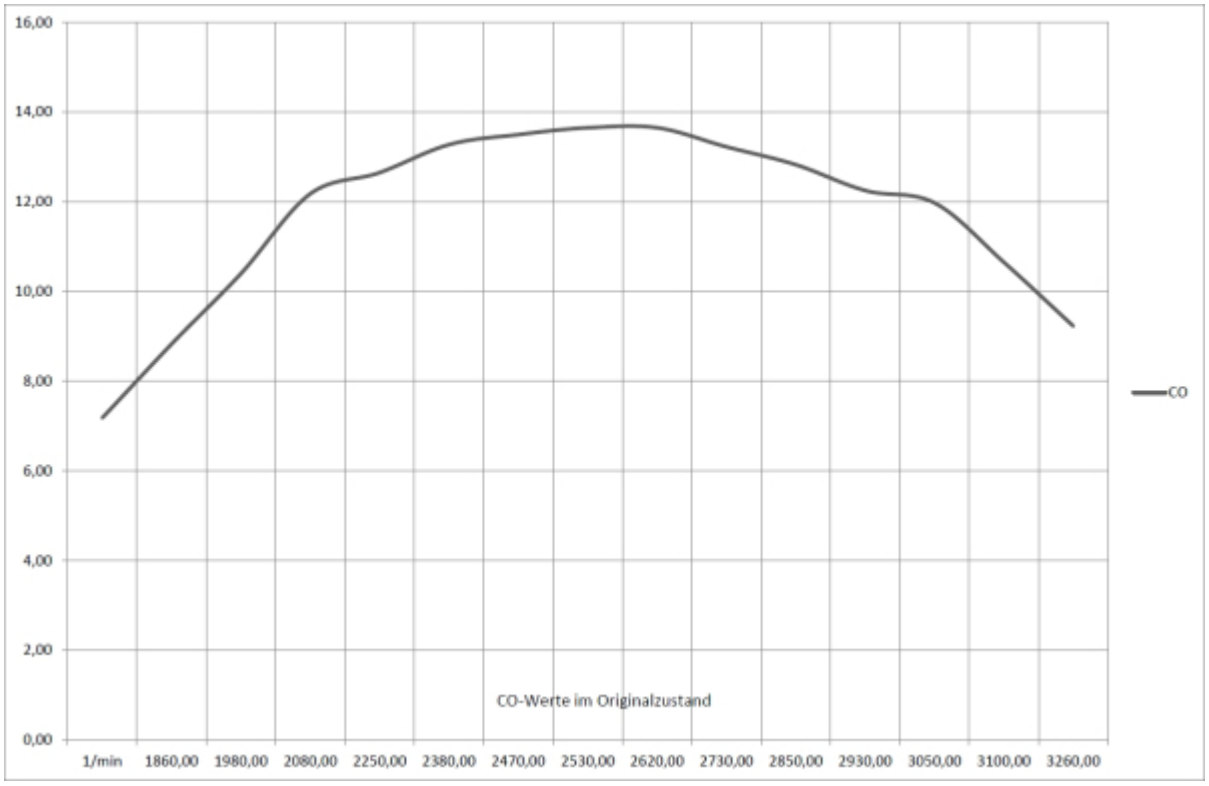
If you now unscrew the spark plugs and look at the spark plug pattern, the insulator is pitch black or the spark plug patterns are completely different.
What is the reason for this? Let's first take a look at a graph that illustrates the CO content of the engine in the low to medium speed range:

If you now look at the speed range in which you roll to the parking area, it becomes clear that the

spark plugs must be black.

With a CO content of approximately 14%, we are in a range where the engine is still just able to process the fuel „poured in“.

So we have to run the engine for several minutes in a range where the exhaust gas values are reasonably „normal“ before switching off.
