The cooling run of the turbocharger

.... and what happens if you don't comply with it

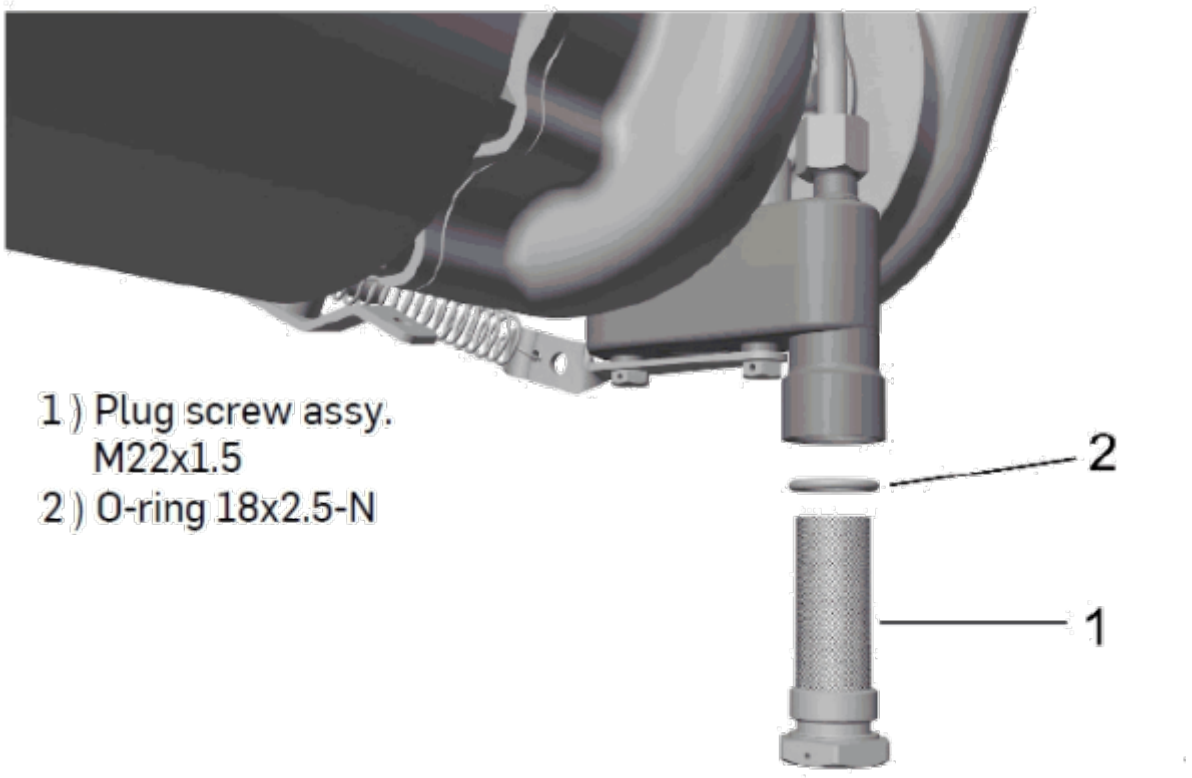
We measured the temperature of the center section and were amazed at how cool it stays.
We fitted the sensor to the oil inlet of the center section of a Turbo-Dimona as a replacement for the copper seal that is fitted under the valve housing.

We had just 120°C in flight after 5 minutes of take-off power. After landing and the cooling run approx. 100°C .

The temperature rose to approx. 130°C after parking.

However, these are temperatures that do not lead to carbonization.
Consequently, carbon formation only takes place on the shaft in the area of the turbine wheel.
