The cooling run of the turbocharger

.... and what happens if you don't comply with it

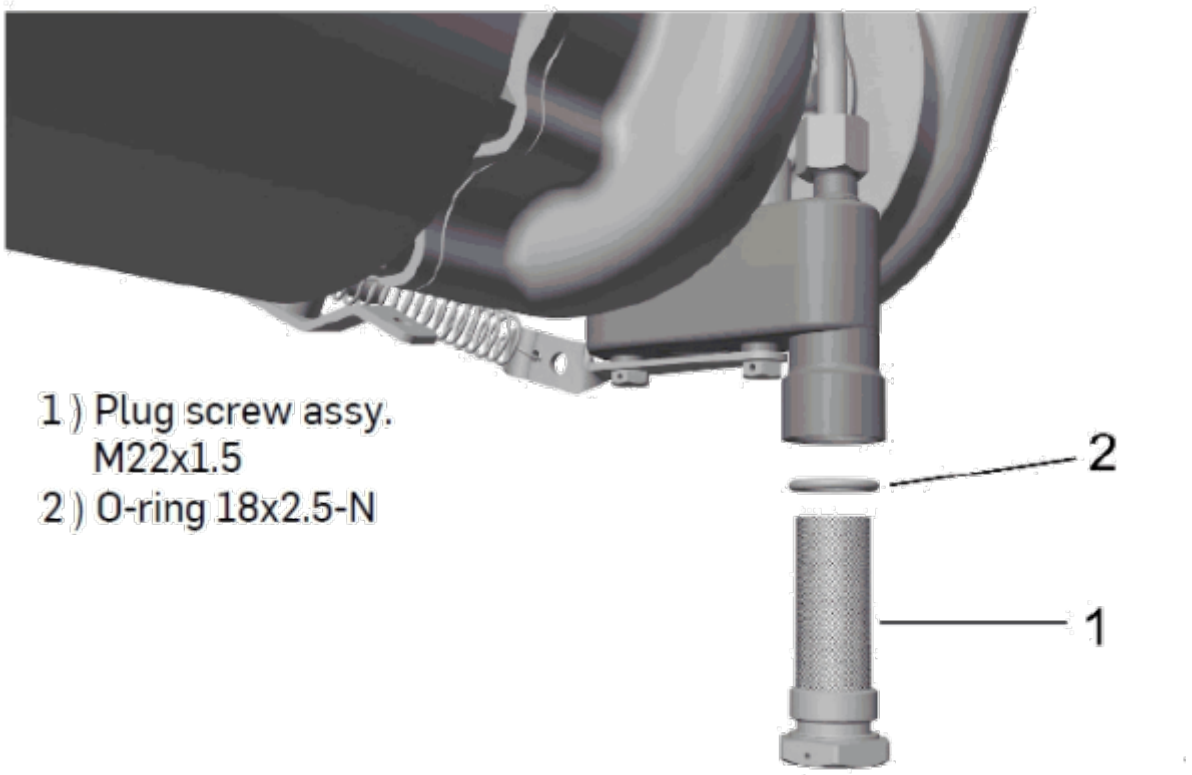
There is now an excellent solution to prevent engine damage caused by carbon crumbs.
See also the
SI-914-039 Introduction of a new oil sump assy for ROTAX Engine Type 914 (Series) from 20.02.2023

A strainer is integrated into the oil sump vessel here, which prevents carbon crumbs of one size from reaching the banjo bolt of the return line, which can clog it.
I recommend everyone to install this unfortunately not quite cheap part.
**However, engine damage is much more expensive.
