The needle nozzle

…. or why their life is more finite than expected …

From:
https://www.kleinjung.de/rotax/ - **Ralle's ROTAX FAQ**

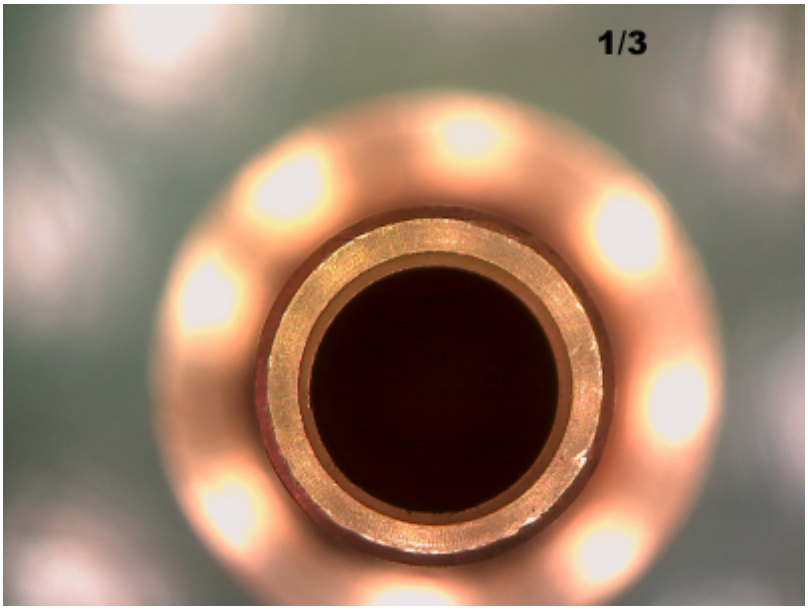
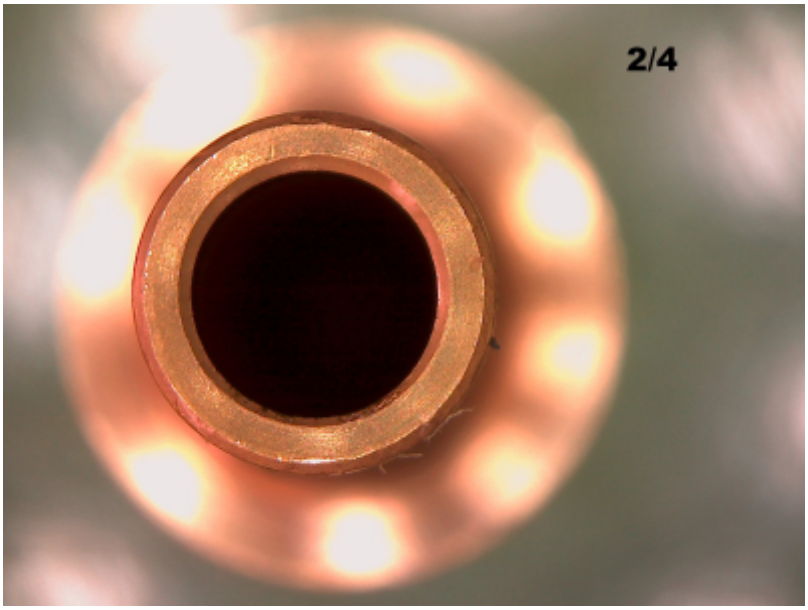
- Float needle valve
- Float suspension

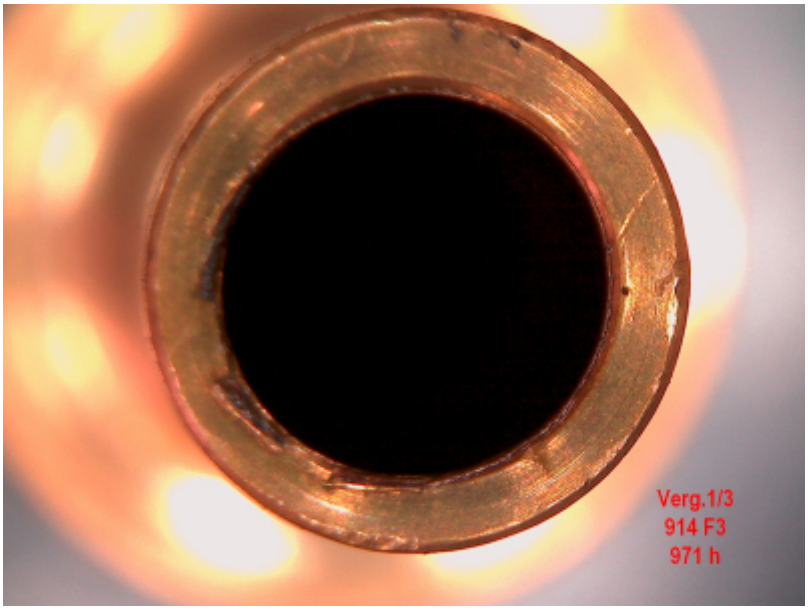
206 operating hours

A flared edge can be clearly seen on the needle jets **with 206 operating hours**, which is caused by the constant beating of the jet needle when the carburetor vibrates.
The needle jets **with 971 operating hours** of a 914 Turbao clearly show that even an engine with a permanently installed airbox can exhibit heavy wear on the needle jets.
One can imagine that the carburetors of an engine without an airbox can show even greater wear.

If the needle nozzle is now deflected, the bore widens and the annular gap becomes larger with the same slide piston height.

This means a significantly richer mixture, as actually specified by the components, and the engine runs worse.
This is most significant in the 912S/ULS (100 hp) Rotax, which becomes very unstable when accelerating gently (2000-2500 rpm) as it is heavily over-rich. See also here...
If you now simply replace the needle nozzle during the 200h check, this problem is immediately minimized or does not occur at all.

Based on my experience with the basic overhaul of carburetors, I have always advocated (including during training courses) that the needle jets should always be replaced during a 200h check.
That didn't go down particularly well with some of those responsible, as they said I was giving the product a bad name.
**Unfortunately, my opinion is different: if you recognize a problem, you should try to fix it.
