# The check valve on the 914 turbocharger

... or why there is a pool of oil under the 914

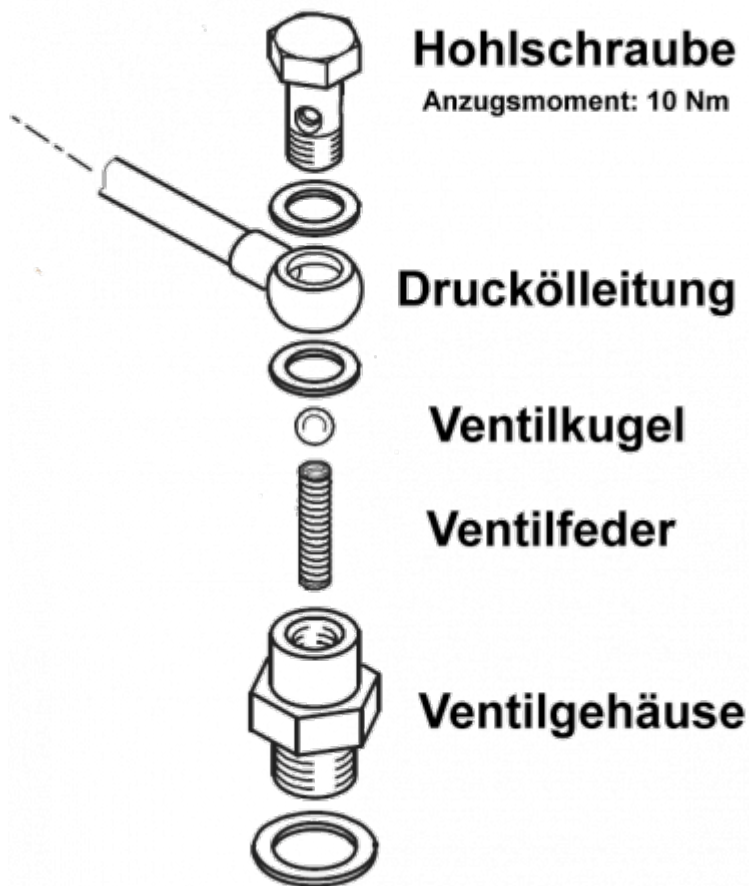
If the non-return valve in the valve housing is not tight, the oil sump will fill up and then the turbine and compressor housing will also fill up.

- The valve housing is mounted on top of the turbocharger.
- There is a compression spring in the valve housing
- which presses the ball above it
- against the banjo bolt.
