how to block the crankshaft correctly with the blocking screw

... and how to avoid dismantling the engine

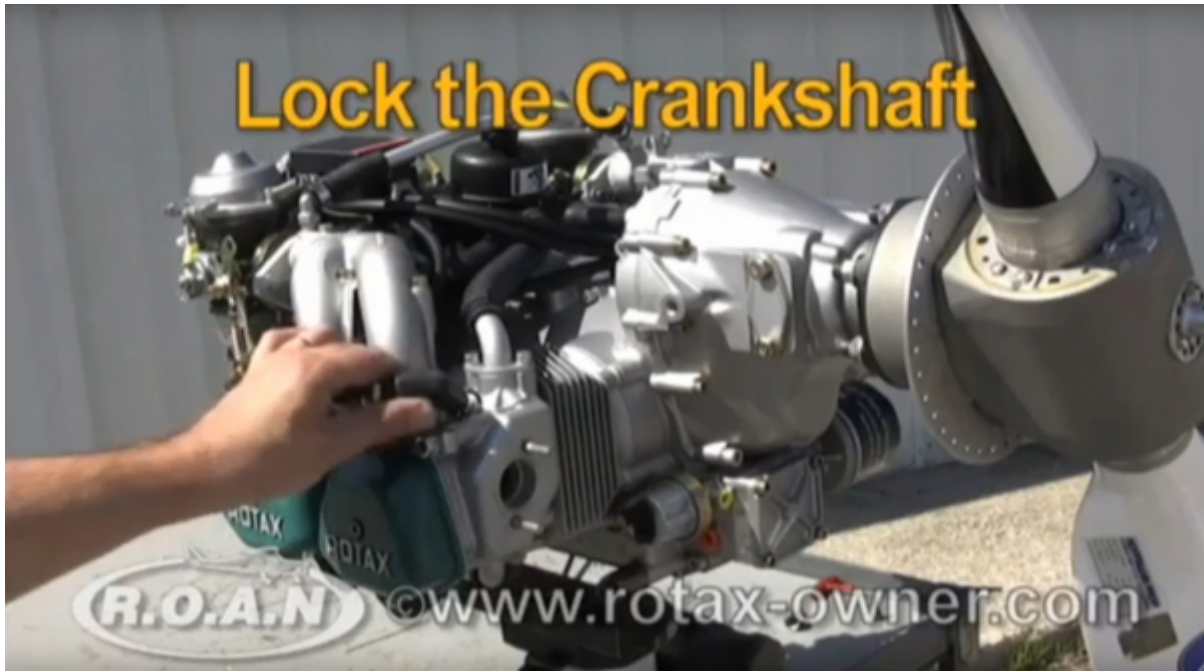
If it is necessary to **lock the crankshaft**, I recommend watching the following video from rotaxowner.com carefully. It is perfectly explained here:

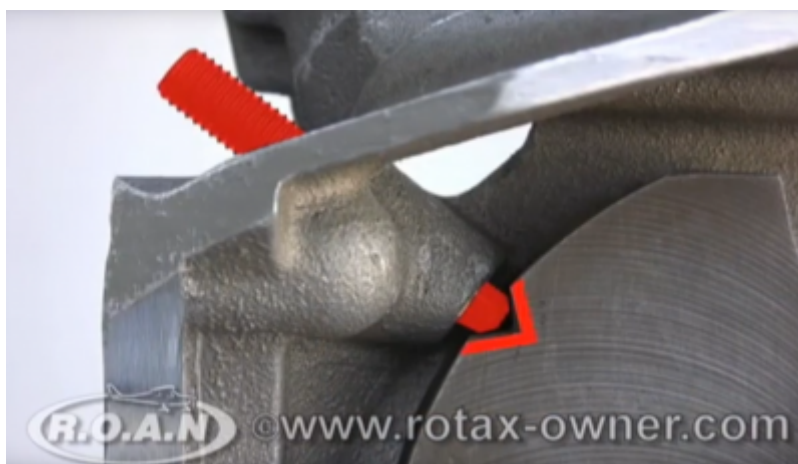
This picture clearly shows how the blocking pin should be positioned

If the locking pin is not screwed correctly into the notch in the crank web, it may protrude into the engine housing next to the crank web when the drive wheel nut is loosened or tightened. As the distance between the threaded end of the hole for the locking pin in the housing and the crank web is greater than when the pin is properly seated in the notch in the crank web, we have a longer lever here. This may cause the end of the locking pin to bend in the crankcase.

There is no tightening torque for the locking pin.
I recommend tightening it here with approx. **12 Nm - 15 Nm**. You could also say **hand-tight**.

Turn the locking pin out again 1/2 to 3/4 turns. Now place a finger on the locking pin and turn the propeller back and forth as far as it will go.

Of course, it should lock again in both directions after a very small angle.

At the same time, you should feel with your finger that the locking pin is moved back and forth a little when the notch in the crank arm touches the pin.
