Permanent oil pressure fluctuations during operation

... when the needle trembles or the numbers do not come to rest

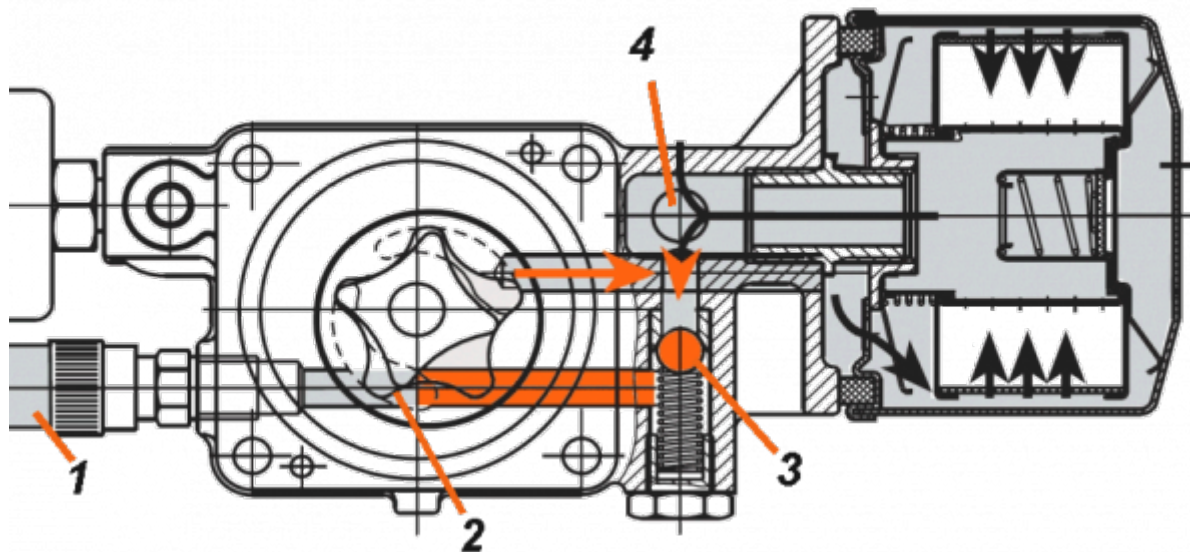
1. Here is the oil supply line connected to the oil pump
2. Here is the inlet to the intake side of the trochoid in the oil pump
3. the oil pressure control valve
4. the oil channel for engine lubrication and the oil pump outlet

Basically, such an oil pump, whether a gear pump or a [Eatonenpumpe](#), has a very high delivery pressure.

This must be reduced/regulated and this is achieved by the oil pressure control valve. The excess oil „regulated“ by the control valve is usually discharged into the engine oil pan.

Here, the oil is fed directly back into the oil supply through the channel shown in red.

The oil return channel after the oil pressure control valve is absolutely the same as the oil inlet from the oil reservoir. This means that when oil is regulated away from the valve, it flows exactly opposite the oil coming from the oil reservoir.

Depending on the oil temperature, delivery rate and pressure of the oil pump and the elasticity of the oil hoses, this can lead to resonances in the entire oil circuit. How the condition is caused is not yet entirely clear to me, but is probably caused by the control behavior of the oil pressure control valve. As I have already written, the installation of the mushroom-shaped valve piston (857230) could possibly lead to an improvement.
