**Austausch der Kipphebel bei ROTAX 912 (Serie)**

**Replacement of rocker arms on ROTAX 912 (series)**

Inspection and replacement of rocker arms

All engines of **Type 912 A (series) from S/N 4,005.196 to S/N 4,380.789 and Type 912 F (series) from S/N 4,412.501 to 4,412.534.**

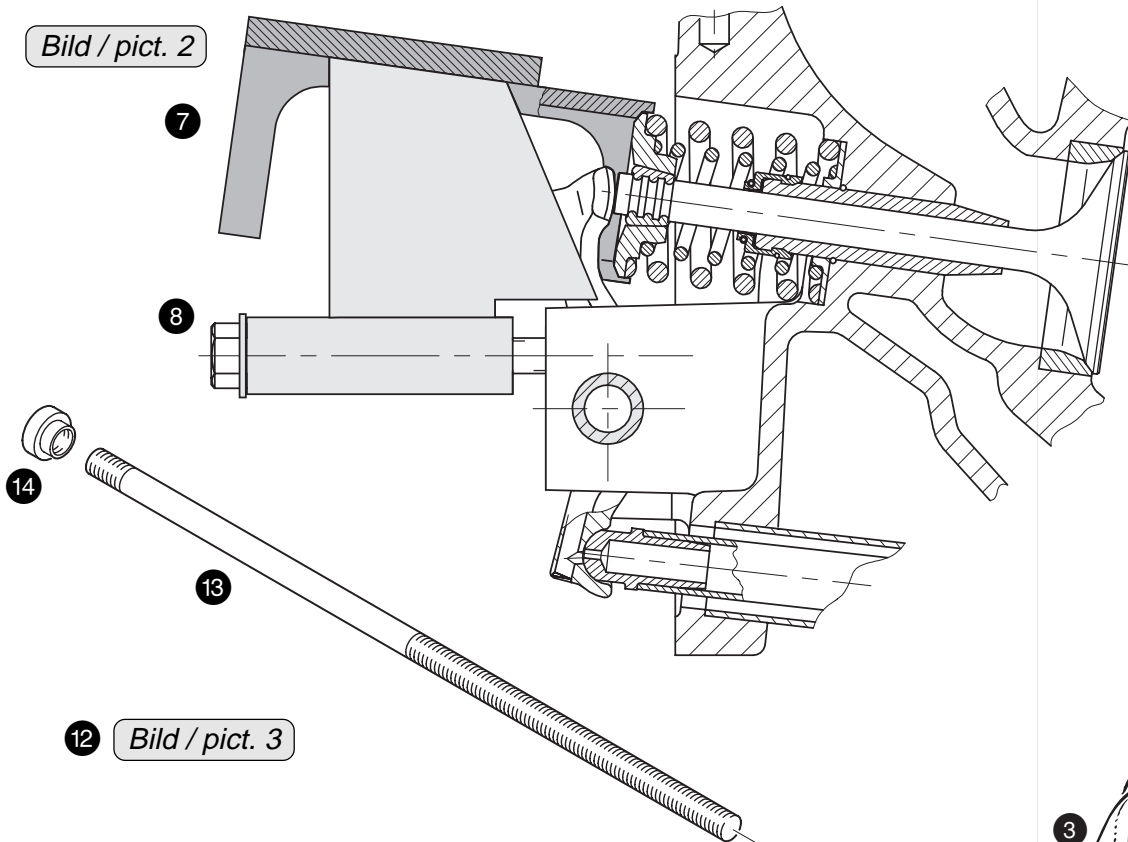
Bild / pict. 2

Turn crankshaft so that the respective piston is on ignition top dead centre. Remove the external cap nut ⑥. Screw valve spring spanner ass'y ⑦, part no. 877 385, with hex. screw ⑧ M6x70 onto the cylinder head and depress both valves by 3 turns, thus releasing both hydraulic valve tappets. Now the rocker arm shaft ⑨ can easily be removed. Withdraw both rocker arms ⑩ and ⑪.

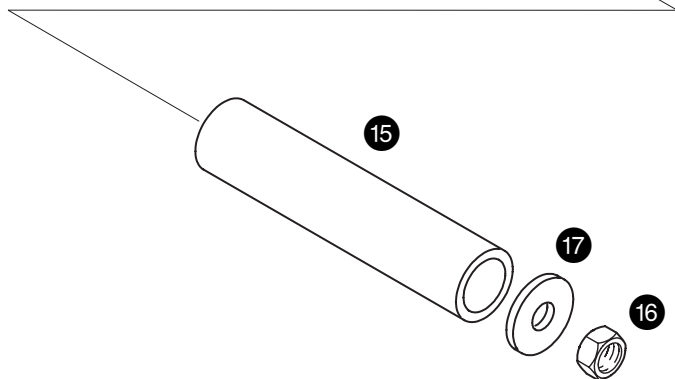
12 Bild / pict. 3

If the rocker arm has traces of seizure, the rocker arm shaft can only be removed with the rocker arm extractor ⑫ part no. 877 770. For this purpose push the threaded bolt ⑬ with the short thread ahead through the hollow rocker arm shaft and screw on the special nut ⑭. Push rocker arm shaft as much as possible towards outside so that the extractor sleeve ⑮ can be centered on it. Fit the extractor sleeve ⑮ and screw on extractor nut ⑯ with washer ⑰. By turning the extractor nut, the rocker arm shaft can be pulled out.

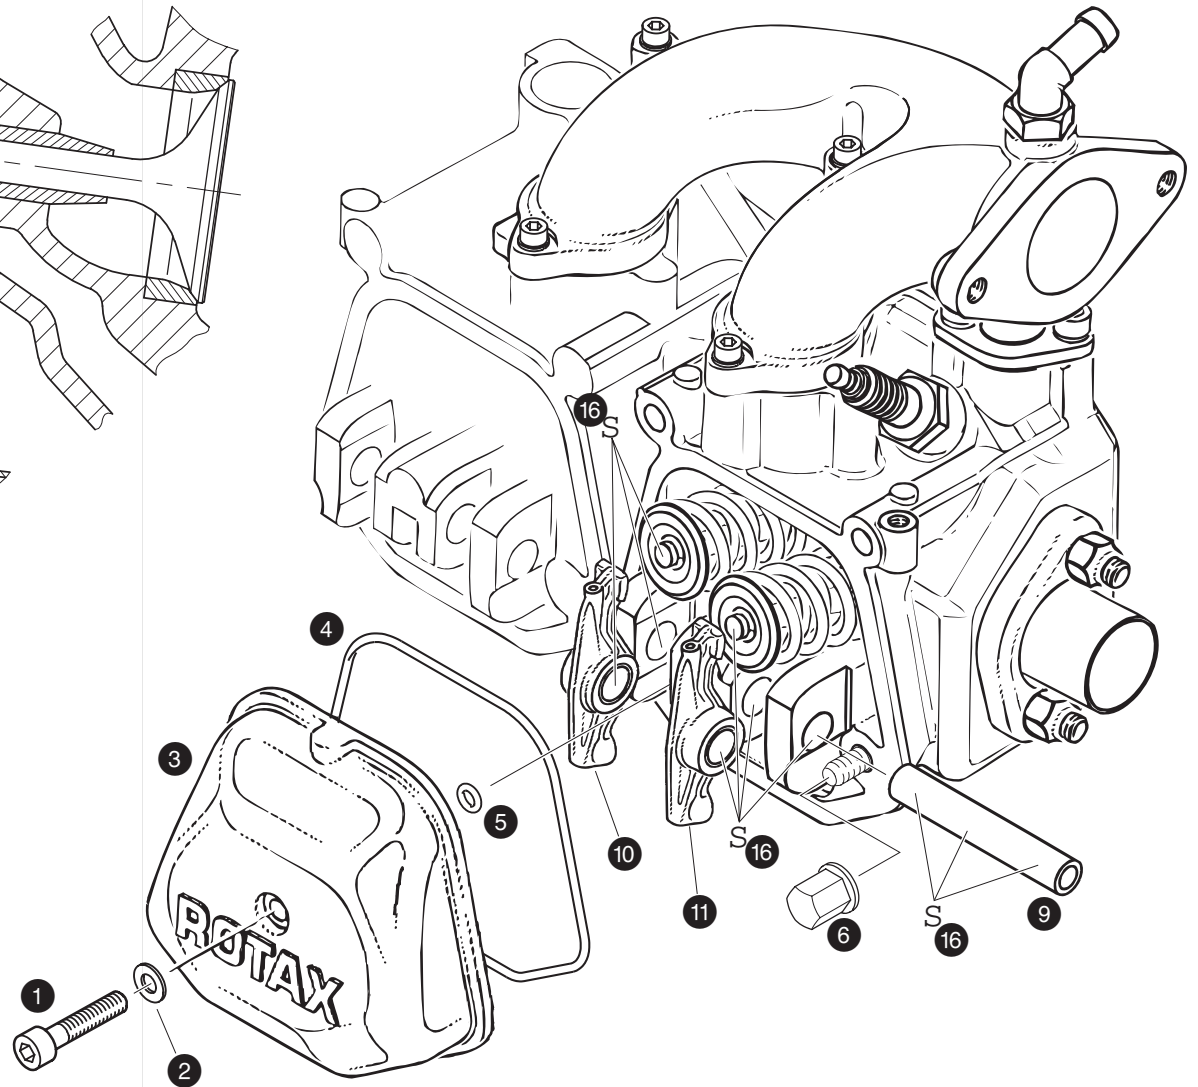
Bild / pict. 1

Remove Allen screw ① M6x25 with washer ② from valve cover ③ and remove valve cover with large and small O-ring ④ and ⑤.

Apply MOLYKOTE G-n 16 to the bore in the new rocker arm, to the push rod tip and valve contact surface. Place inlet rocker arm 10 and outlet rocker arm 11 into position, apply MOLYKOTE G-n 16 on both ends of rocker arm shaft 8 and insert it into its seat in cylinder head.

Lubricate all moving parts in the rocker arm space. Insert new O-ring 4 105x2,5 and O-ring 5 6,4x1,8 into the valve cover 3. Clean the sealing surfaces, fit valve cover and tighten the Allen screw 1 M6x30 with washer 2 to 10 Nm (90 in.lb.). Repeat the procedure on all 4 cylinders.
